# Australian Ultralight Federation Inc

## ACCIDENT REPORT CAPELLA AIRCRAFT, GAPSTED, 3 Nov 2002

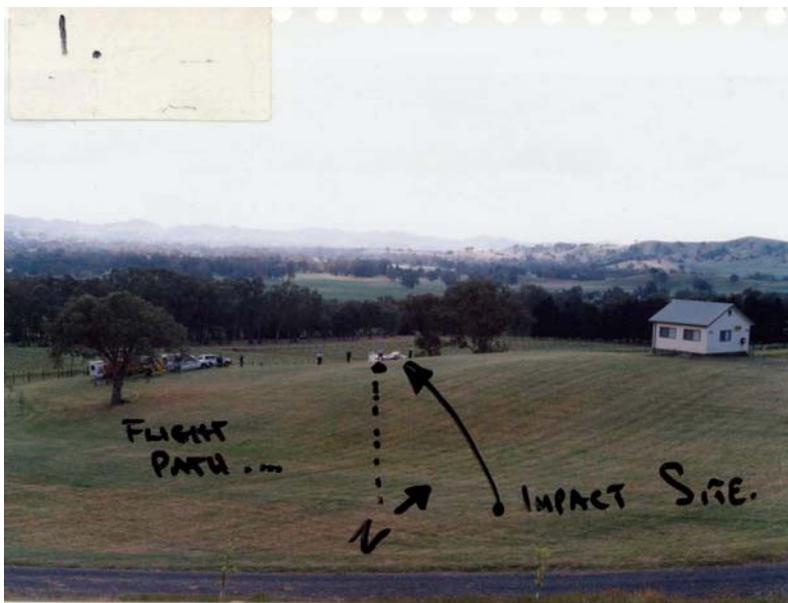
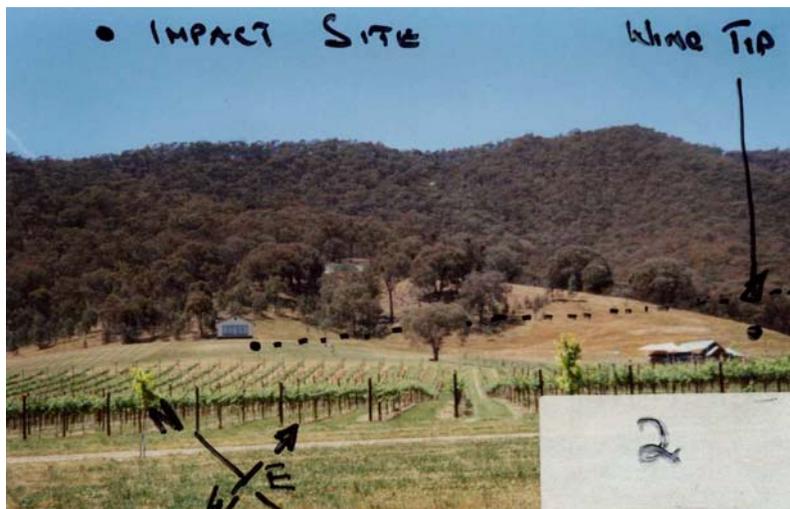
**2.1 Location Photos 1/2:** The aircraft had impacted the ground almost on the apex of a small rise and about half way down the slope in a lawn area within the grounds of the Gapsted Winery.

- The engine ran normally when tested.
- The wind direction and strength combined with the topography at the accident site (see photo 2) would have combined to produce a small standing wave with the downwash just to the south of where it is indicated that the wing tip was found. An aircraft approaching at minimum speed and tree top height could expect significant sink in that area! This could translate to loss of speed if the pilot was concentrating solely on touching down on a given spot.

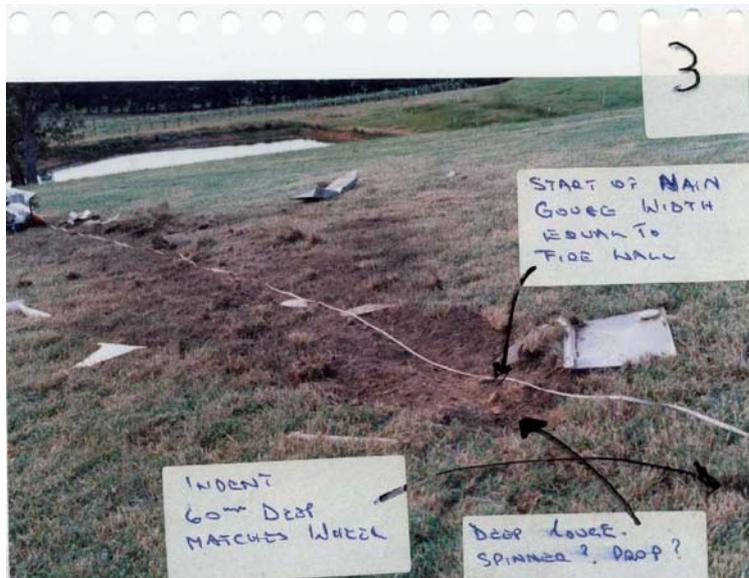
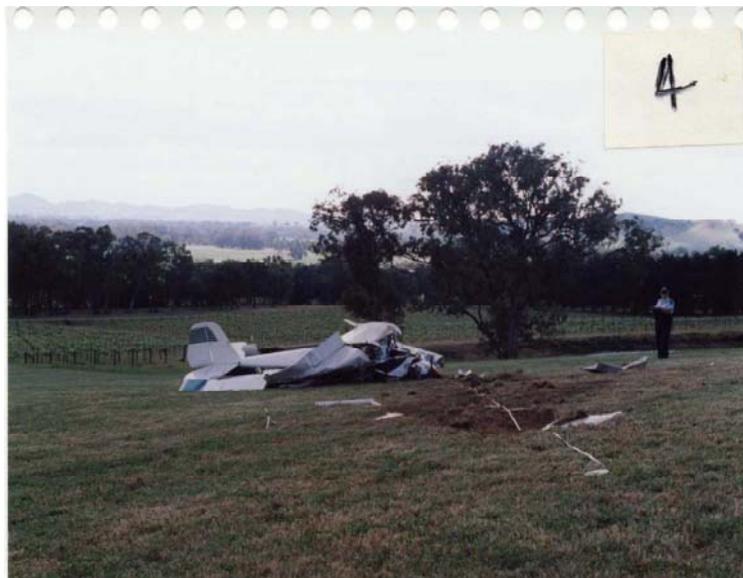
Photos 3/4: Initial inspection indicated that the aircraft had been travelling in a Northwesterly direction when it impacted the ground, skidding along that path whilst at the same time slewing right. The aircraft came to rest facing to the North, approximately 12.8 metres from the initial point of impact. Although damage to the aircraft was extensive it was found to be basically complete. With the exception of the starboard wing tip and the starboard undercarriage leg and wheel (later found), aircraft components and fragments of the aircraft were found along the path from the initial impact point to the point where the aircraft had come to rest.

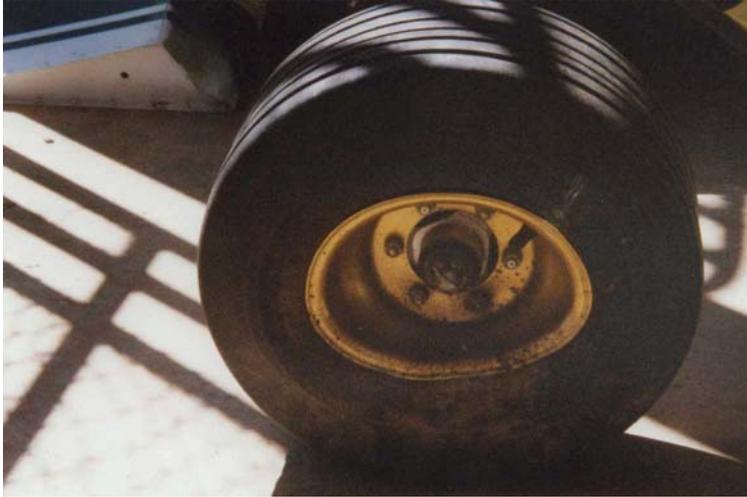
1st impression in the ground matches wheel size.

Photo 5: Right main wheel has significant compression damage.  
Right main undercarriage leg and right lift strut bracket torn from their respective mounting points at the fuselage, Leg with wheel attached later found 70 metres diagonally and down-hill of initial impact point.  
The right wing tip was later found 130 metres rearward of the impact point.

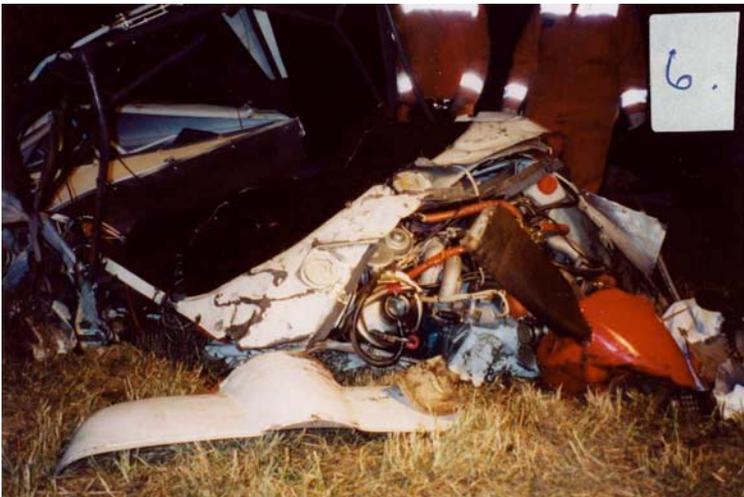
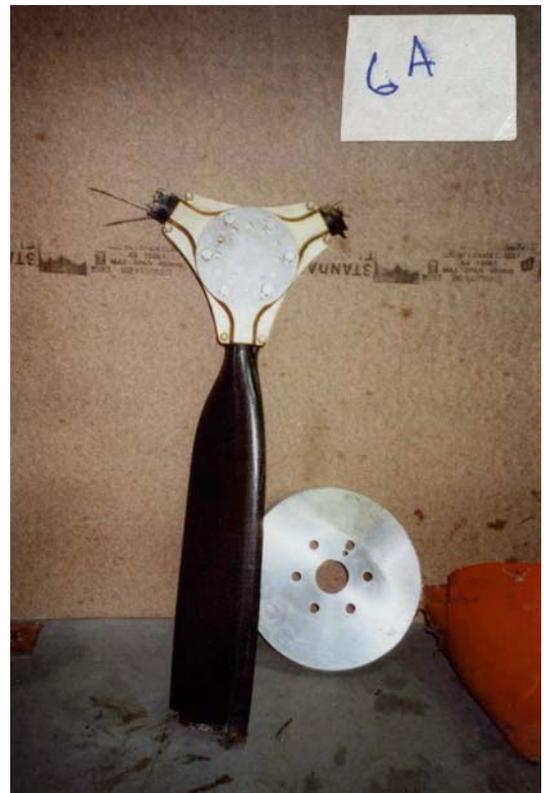
Photo 6/6a: Damage to the propeller spinner was contained to an area of about 50% of its radius. Two blades of the 3 blade composite propeller were severed at their base with the remaining blade severed at a point approximating half the blade length; the propeller hub was not damaged. The damage is consistent with an engine delivering minimal power at

time of impact.

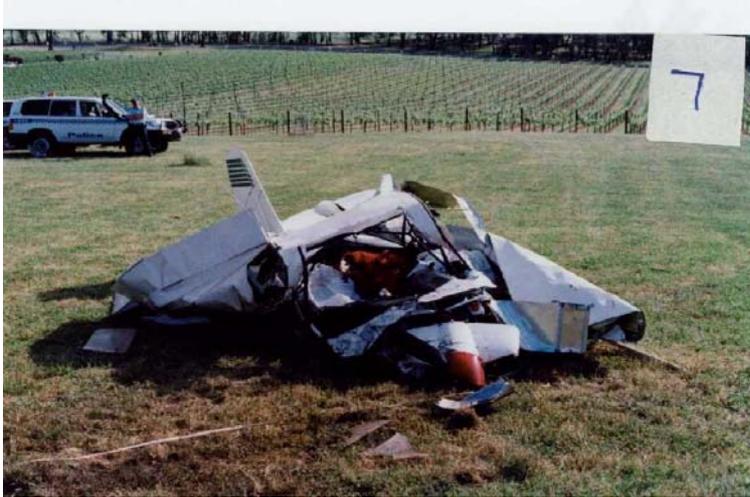
Photo 7: The engine had skewed to the right and downward, consistent with damage to the firewall and right side cockpit area. No 1 cylinder (front right) was cracked and the water inlet pipe was broken, additionally the push rod tubes and exhaust to that cylinder were compressed upwards. Both carburetors were torn from their rubber mounts and both air cleaners were crushed.

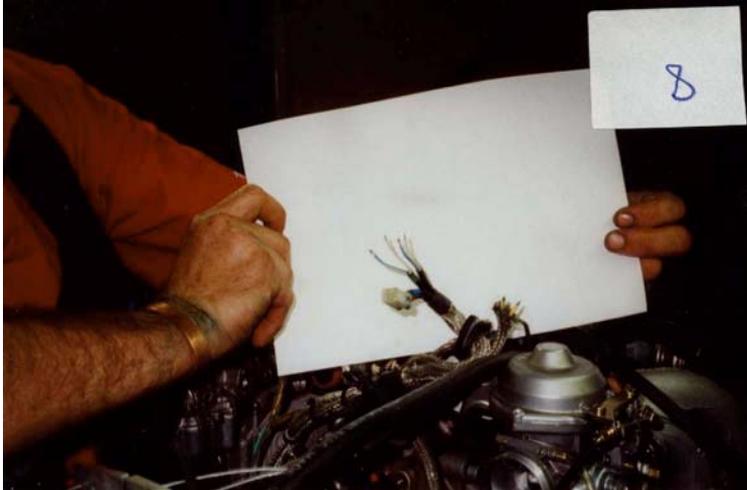
Photo 8: The Engine stator magneto housing had contacted the firewall mounted fuel tank, which had severed cables to the ignition system. The firewall mounted fuel tank had ruptured.

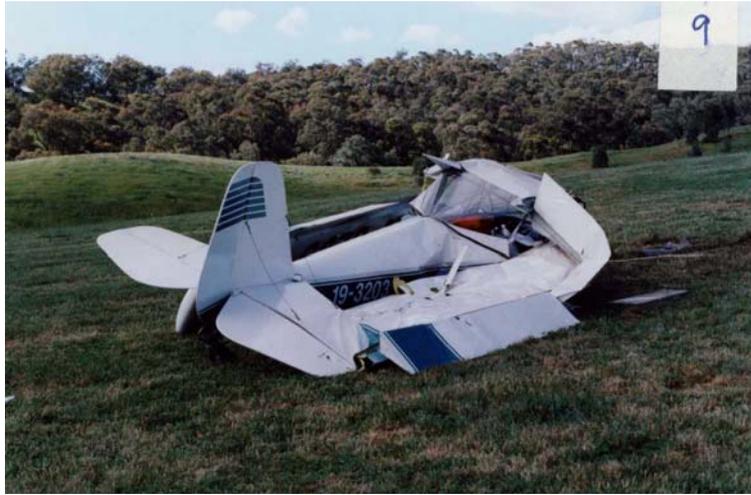
Photo 9: The right wing had failed at the forward root attachment. The wing leading edge has collapsed downward and then folded rearward coming to rest inverted parallel to the fuselage.

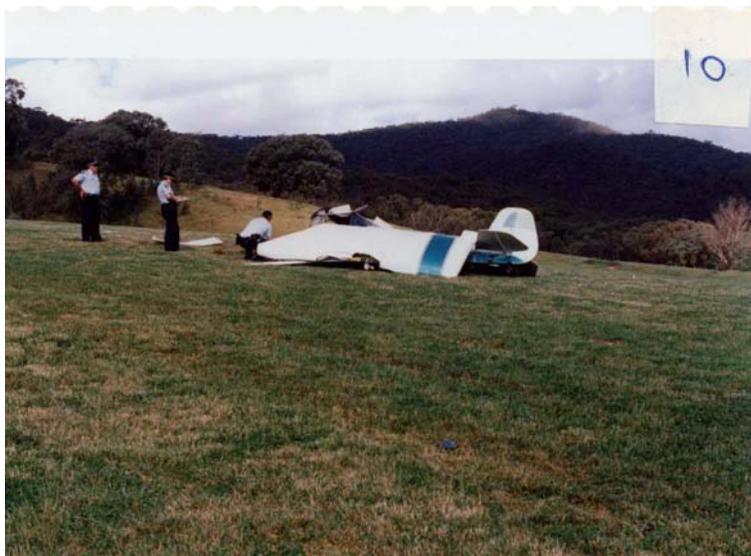
Photo 10: The left wing strut failed at the attach point at the fuselage similar to the right hand side, the wing separated at the forward root attach point coming to rest along-side the fuselage. The flap in its entirety had separated from the wing after contacting the fuselage. Failure of both left and right forward wing root attachments appear to follow strut failure.

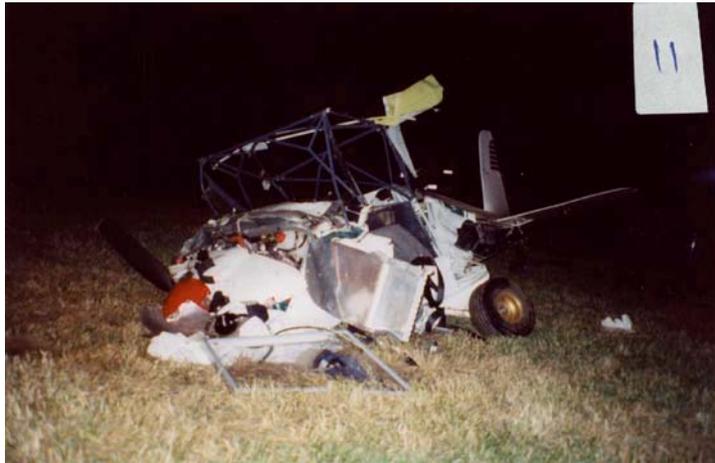
Photo 11: The left undercarriage leg had collapsed outward and at right angles to the fuselage. Consistent with heavy vertical down force.

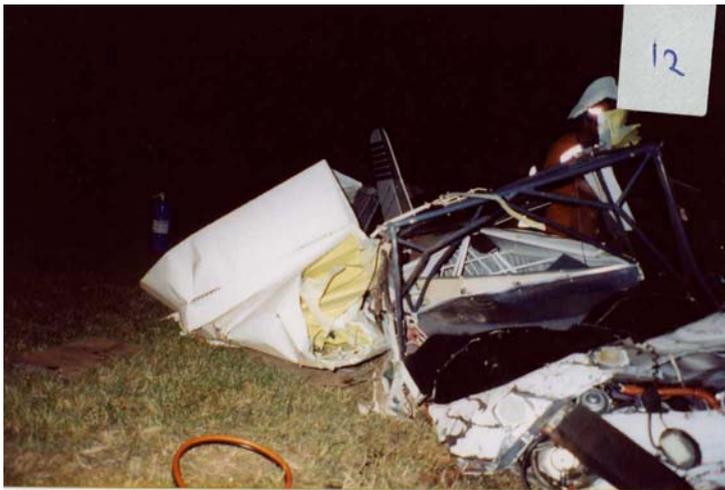
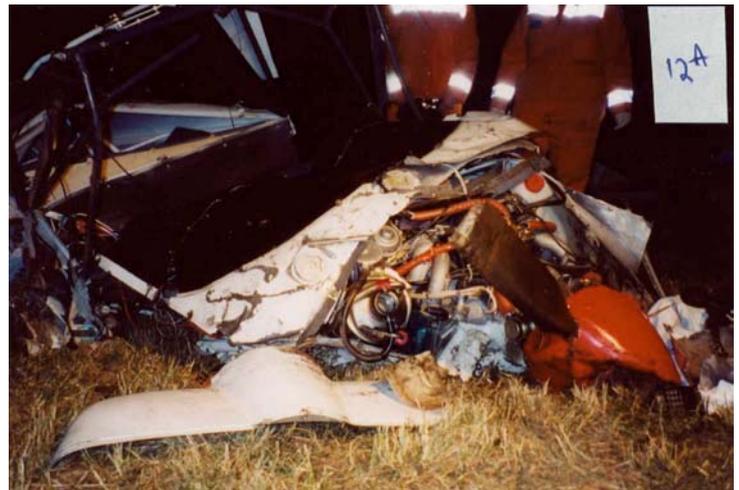
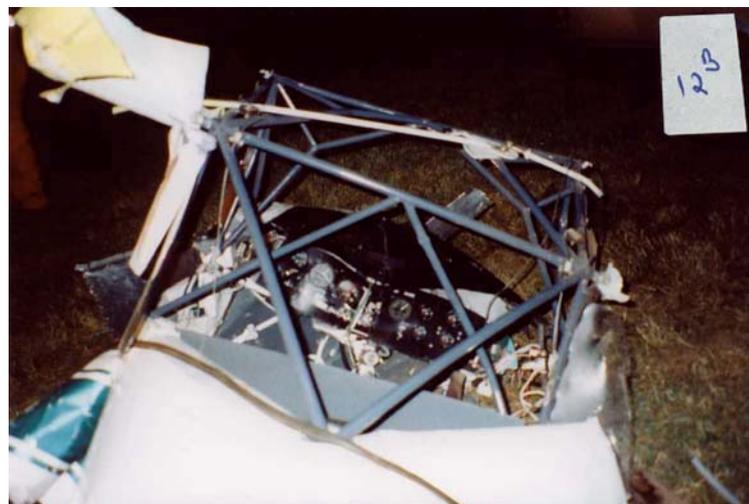
Photo 12/12a/12b: Damage to the cockpit cage is concentrated mainly on the right hand side and below the window line it appears that the greatest force was applied upward and then rearward.

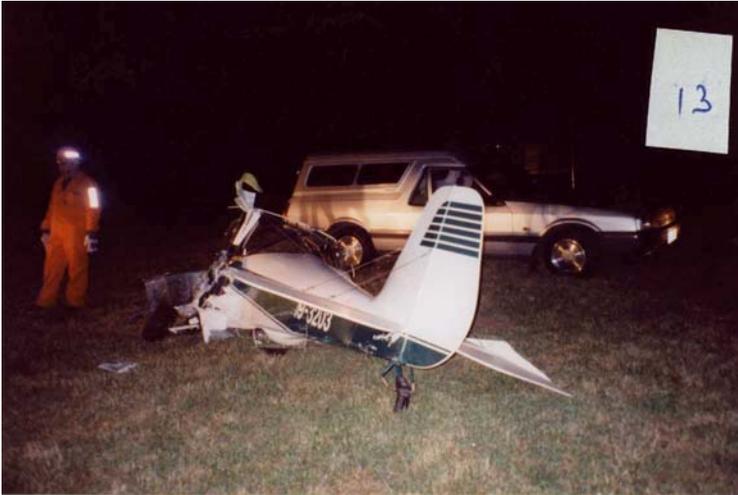
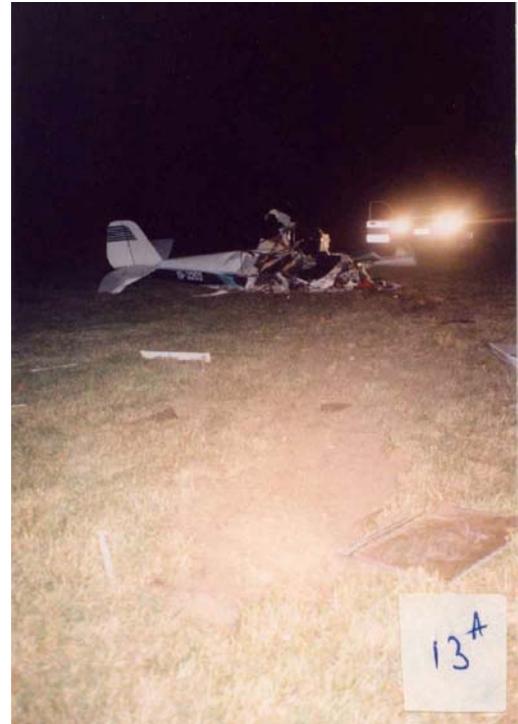
Photo 13/13a: The fuselage rear of the cockpit area was in the main undamaged, the exception being that the right side horizontal stabiliser at the outboard tip was damaged after the right wing had made contact.

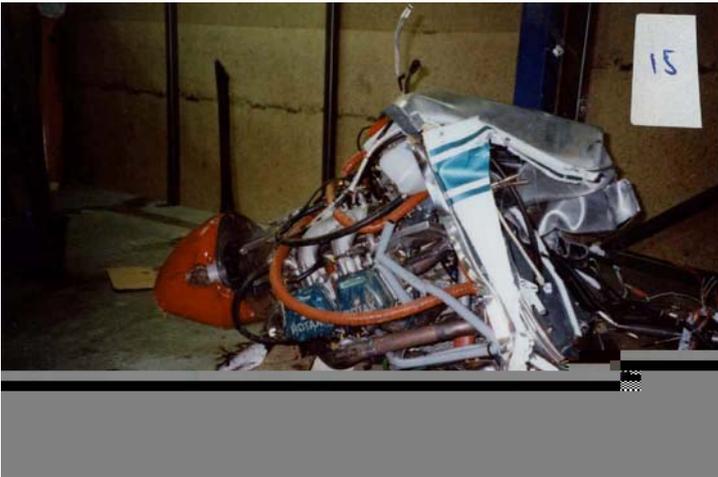
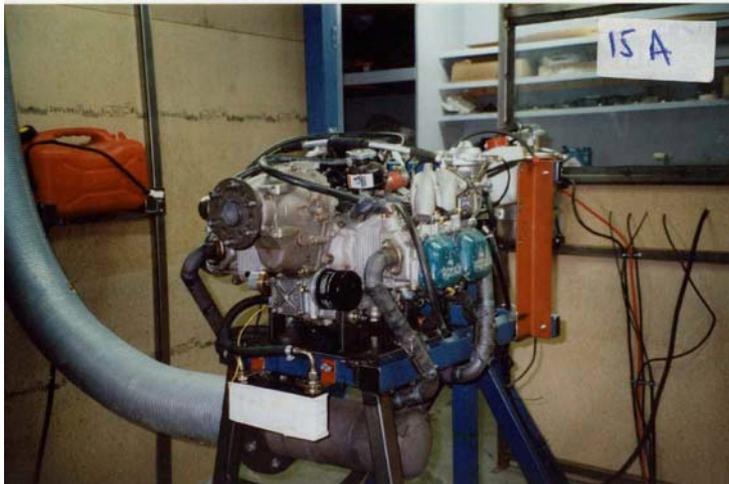
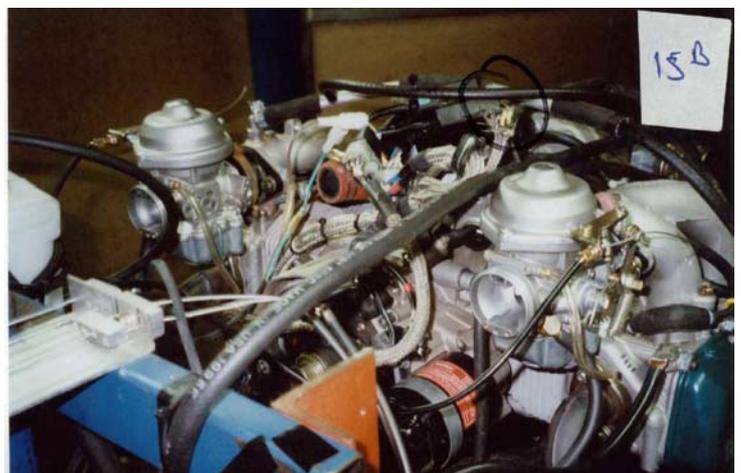
Photo 15/15a/15b:

A 3mm triangular piece of fuel line was found in the fuel line on the outlet side of the fuel filter, this piece together with a fuel sample was delivered to the Coroner's office for analysis.

The engine was removed from the aircraft and transported to an Engine Specialist for inspection. Other than impact damage (see section "impact damage" paragraphs; photo 7 & 8) the engine appeared to be complete.

The engine was started (fired instantly) and after initial warm up it was found to perform as normal.

The mechanical engineer stated "It is my opinion that the engine would have been operational at the time of the accident.
