A U S T R A L I A N   T R A N S P O R T   S A F E T Y   B U R E A U

AIR SAFETY INVESTIGATION

**INVESTIGATION REPORT  
200100213**

**Boeing 737-400, VH-TJX  
Brisbane, QLD  
18 January, 2001**

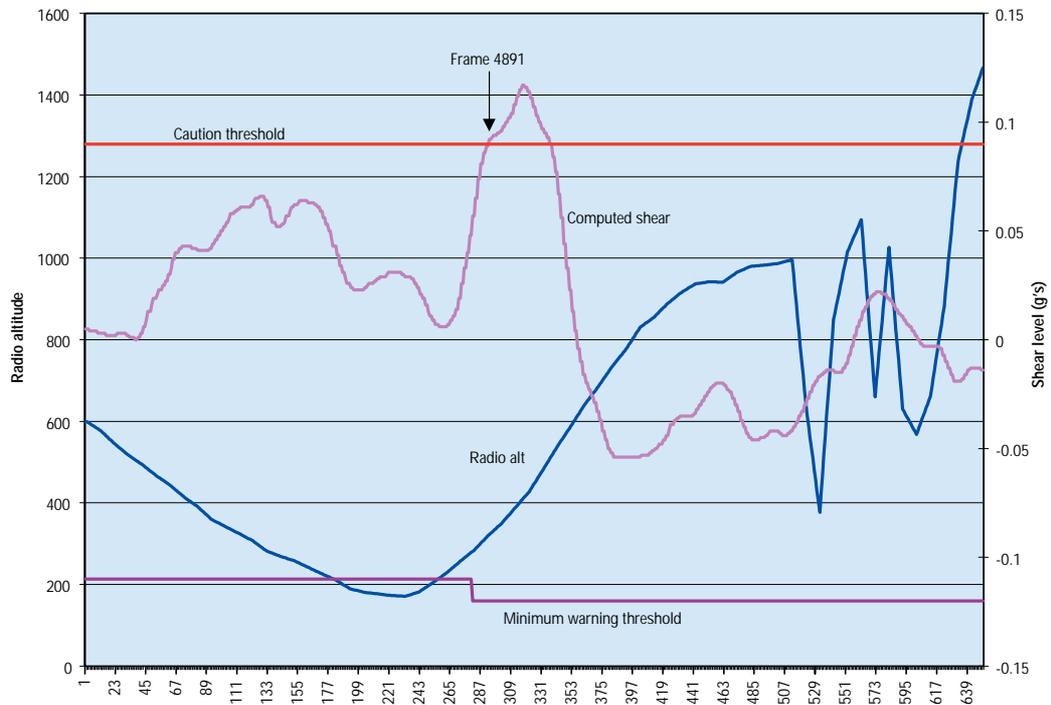
**Figure 1:  
Shear level**

As stated above, the windshear caution option was not enabled on the aircraft. If enabled, it would have provided the crew with a windshear caution alert about 24 seconds prior to the first GPWS 'Terrain' warning, and about 31 seconds prior to the GPWS 'Pull Up' alert.

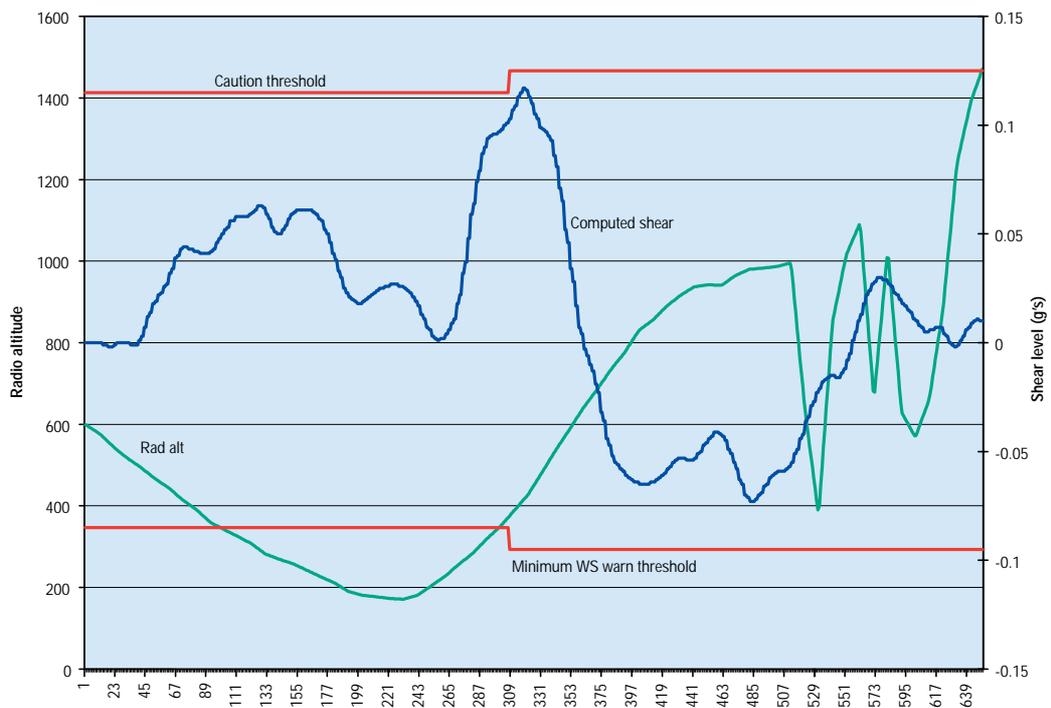
**Figure 2:  
Honeywell windshear algorithm**

The recorded flight data was also examined using the Honeywell windshear algorithm. The negative shear level that was derived from that data did not reach the value required for a windshear warning using the Honeywell algorithm. The algorithm also had a higher windshear caution alert threshold than the Boeing algorithm, and provided no caution alert. The Honeywell windshear algorithm is depicted in figure 2.

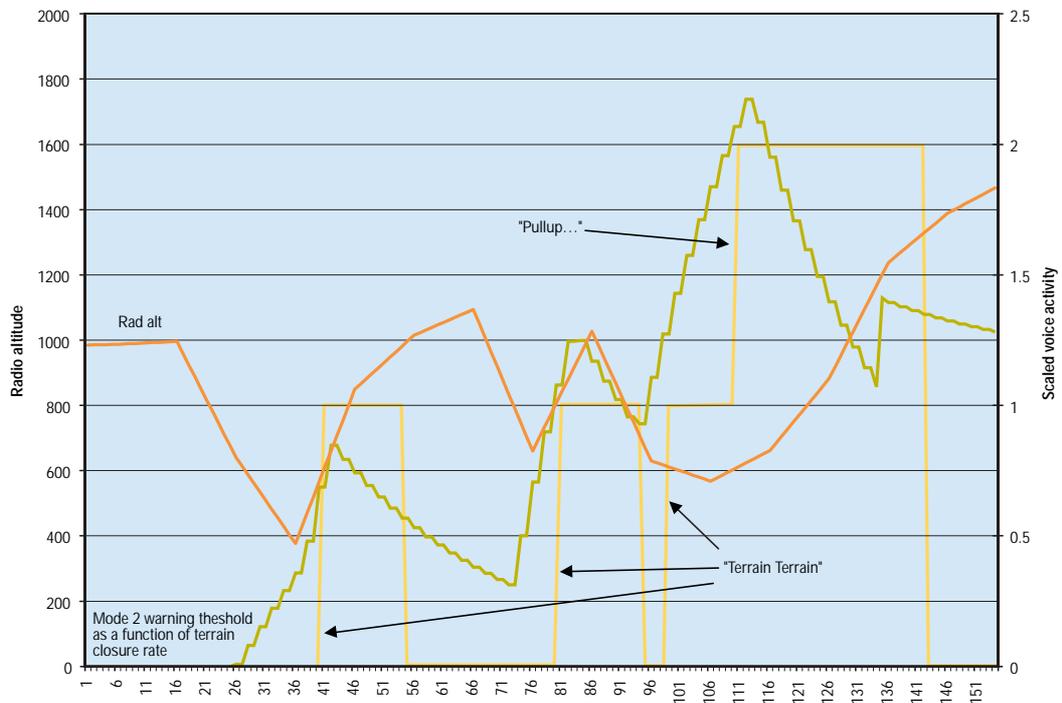
**Figure 3:  
GPWS Mode 2 warnings**

When operating in Mode 2, the GPWS monitored radio altitude (radar altimeter) and radio altitude rate of change, barometric altitude, and aircraft configuration. If the Mode 2 terrain closure-rate parameters were exceeded, the GPWS would provide two different aural warnings to the crew. Those were an aural warning of 'Terrain', repeated twice, then by a repeated aural warning of 'Pull Up'. The radio altitude from the flight data was used in a simulation to investigate the GPWS Mode 2 warnings that occurred during the go-around sequence. The simulation resulted in two 'Terrain' aural warnings at 0729:36 and 0729:38 (timeframes 4921 and 4923), and one 'Pull Up' warning at 0729:39 (timeframe 4924), as shown in figure 3.

Another ‘Terrain’ warning was shown as having occurred during the simulation at about 0729:30 (timeframe 4915). During the occurrence, that alert did not actually take place. The simulation used one-second updated radio altitude, rather than 20 Hz in the aircraft, and the different sampling rate resulted in the radio altitude barely ‘nicking’ the warning curve and technically generating that ‘Terrain’ warning.

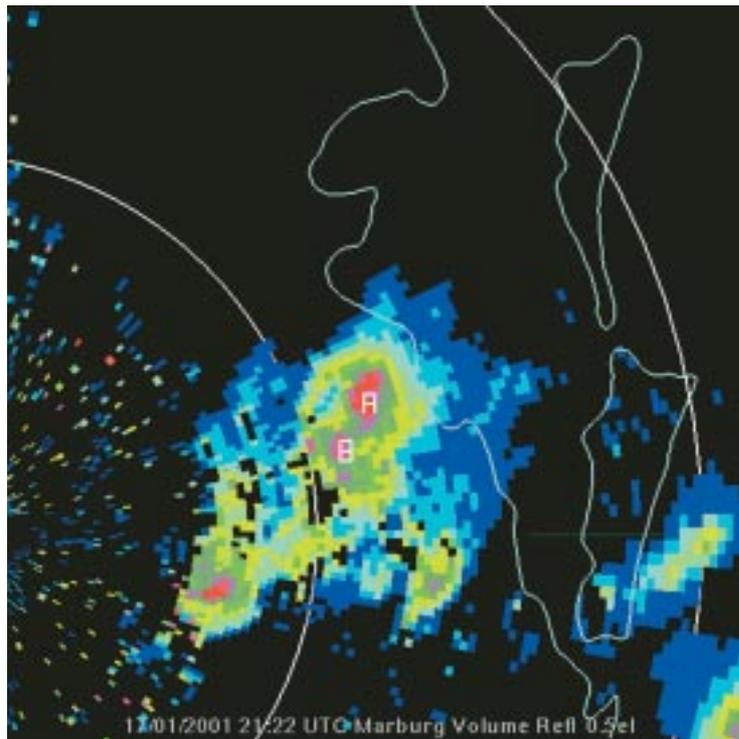
**Figure 4:**  
**Marburg Radar – 18 January 2001, 0722 EST**

Data from the Marburg weather radar was subsequently examined, and revealed that the thunderstorm was a multicellular storm. It was moving north-east at a speed of about 60 kph, and contained two main reflectivity cells, shown as A and B in figure 4. By 0732, a new cell (C) was evident on the northern flank of the leading cell. Figures 4 and 5 depict the movement of the thunderstorm between 0722 and 0732. The radar range rings shown were 50 km and 100 km from the radar.

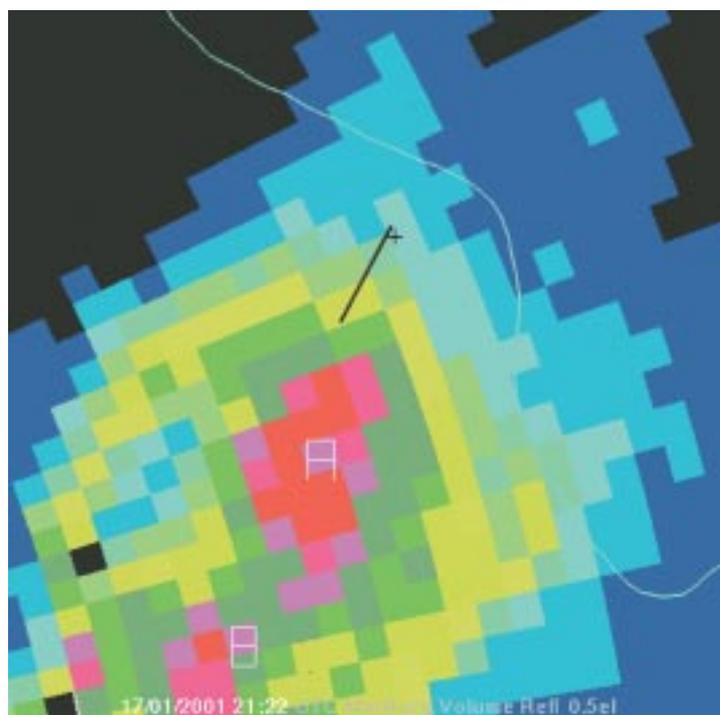
**Figure 6:**  
Marburg Radar – 18 January 2001, 0722 EST expanded data

Figures 6 and 7 are higher resolution images showing the movement of the storm during the same period. The solid black line shows the position of runway 19 at Brisbane aerodrome. The location of the BoM anemometer is shown with a '+', adjacent to the threshold of runway 19. The radar data revealed that thunderstorm cells A and B passed south of runway 19, and that thunderstorm cell C developed over the runway during the period 0722 to 0732.

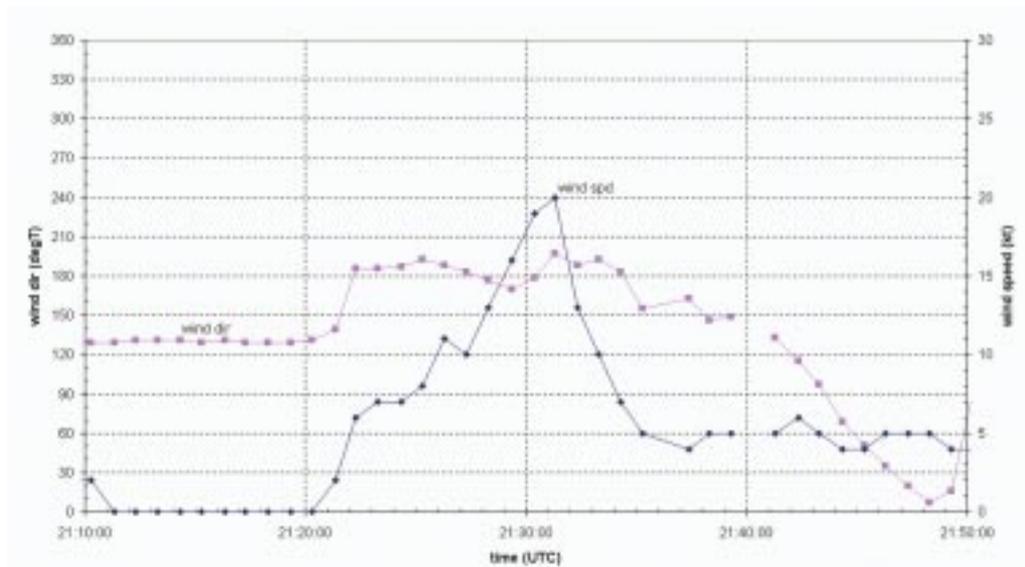
**Figure 8:**  
**Brisbane aerodrome anemometer data – 18 January 2000**

The BoM anemometer at Brisbane aerodrome was located adjacent to the threshold of runway 19. The 1-minute-mean data from the anemometer revealed that shortly after 0720, the wind speed began to increase. By 0732, it was about 20 kts, with gusts up to 26 kts. During the same period, the wind direction shifted from about 130 degrees to 180 degrees. The wind speed and direction is shown in figure 8, with the time scale in UTC (21:30:00 UTC = 0730 EST).

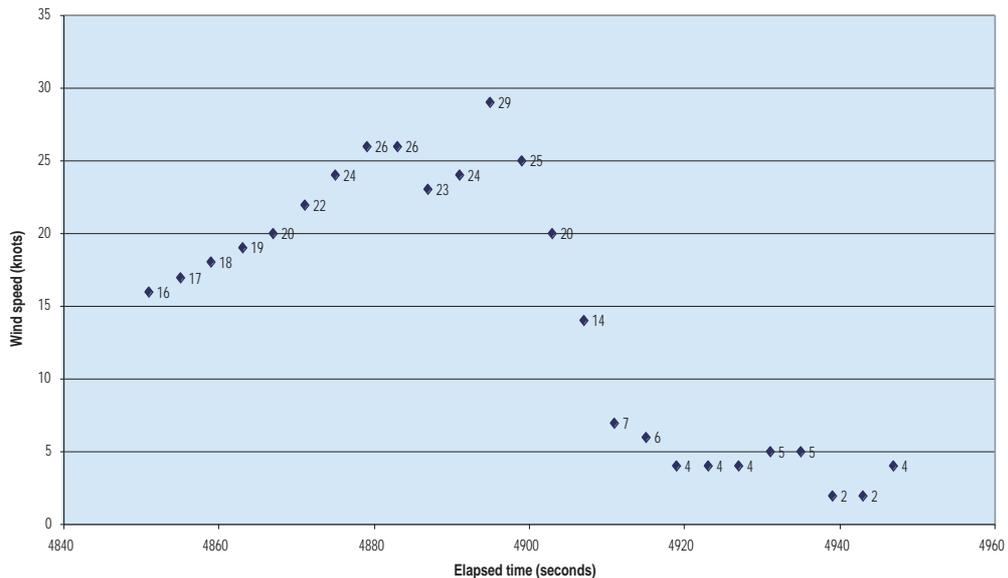
**Figure 9:**  
**TJX SSFDR wind speed data**

The aircraft's SSFDR wind speed data correlated with the BoM anemometer data, and is shown in figure 9 below (timeframe 4900 = 0729:13 EST)

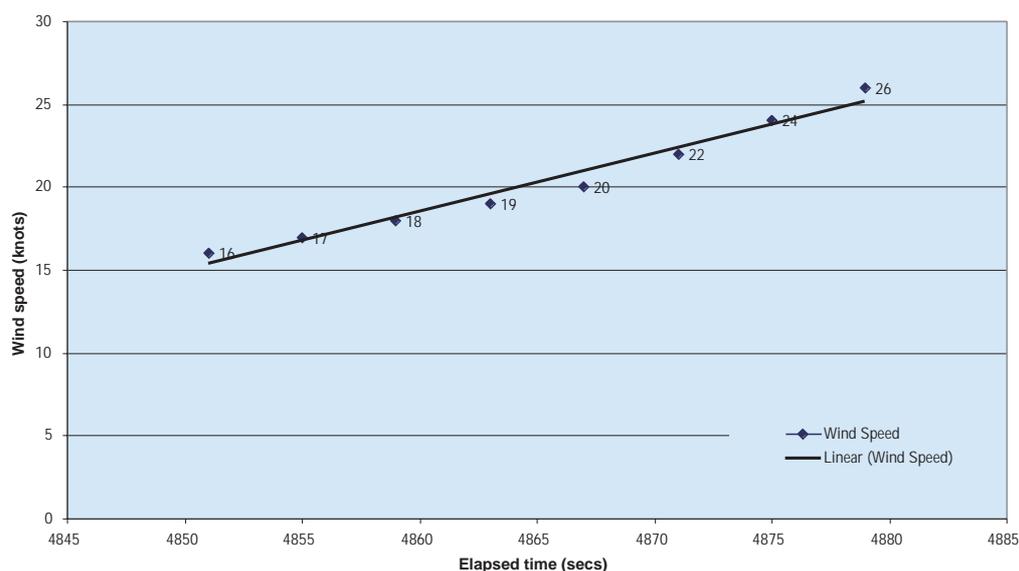
**Figure 10:**  
**Increasing headwind**

The SSFDR wind speed plots indicated that the aircraft experienced increasing headwind conditions during the missed approach manoeuvre, which were then followed by decreasing headwind conditions. Those conditions were typical of a microburst windshear encounter. In the 30-second interval between 0728:25 and 0728:55 (timeframes 4850 and 4880), the aircraft encountered a steadily increasing headwind from 16 kts to 26 kts. See figure 10.

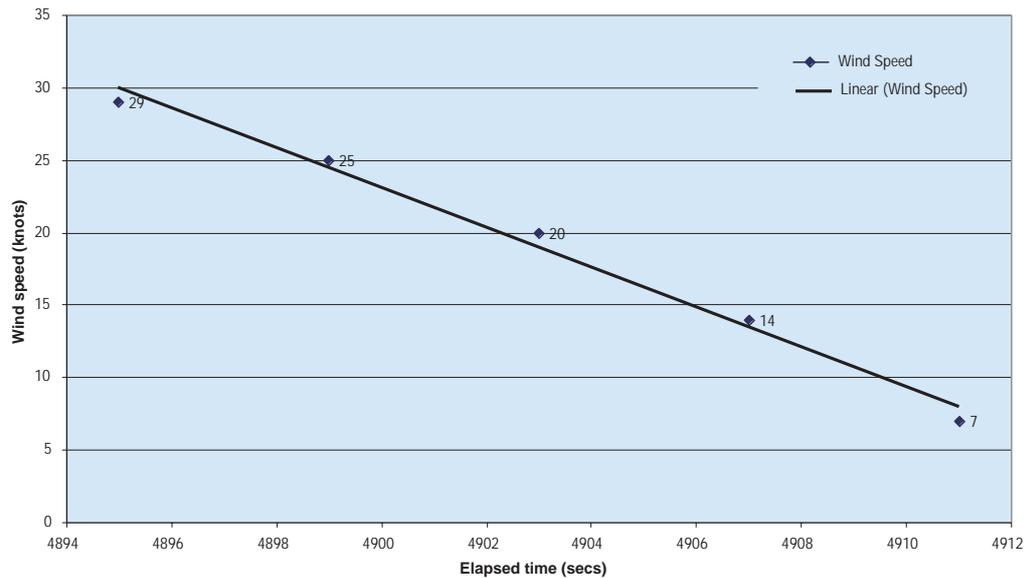
**Figure 11:**  
**Decreasing headwind**

In the 15-second interval between 0728:55 and 0729:10 (timeframes 4880 and 4895), the headwind fluctuated between 23 and 29 kts, peaking at 0729:10 (timeframe 4895), then during the next 16 seconds, the headwind steadily decreased to seven kts. See figure 11.
