ATSB TRANSPORT SAFETY REPORT

Aviation Research and Analysis - AR-2009-041

Avoidable Accidents No. 1

Low-level flying

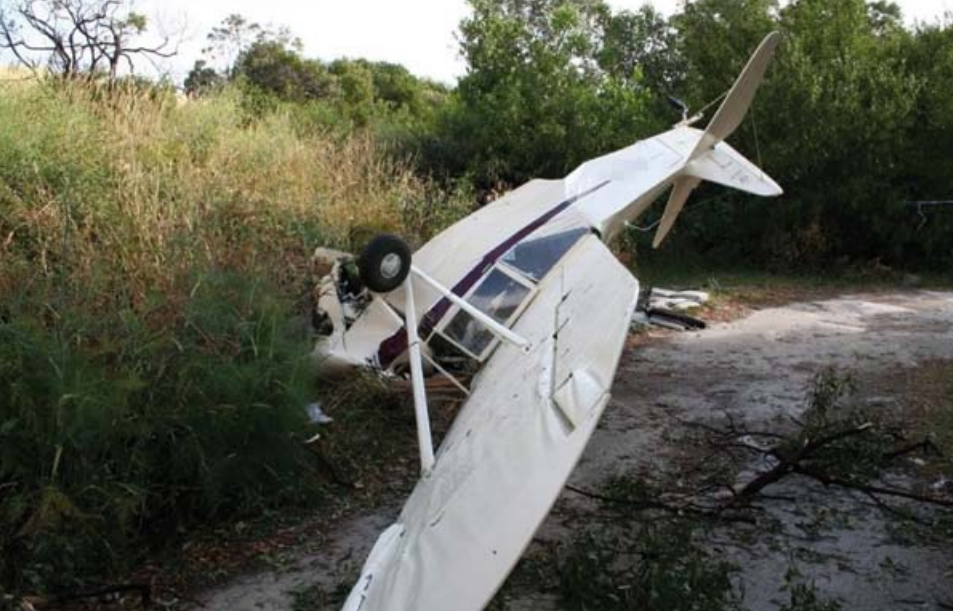
Wreckage of the Auster-J1B

As the aircraft approached the hangars, it climbed suddenly and hit powerlines that passed across the gap between the hangars. Investigation of the wreckage found that the aircraft propeller took the full force of the wirestrike, causing the propeller to disintegrate and the engine to stop. The aircraft aerodynamically stalled at a low altitude, possibly due to the pilot's attempt to avoid trees directly behind the powerlines. Due to the pilot's low altitude, he had little margin to recover from the stall, and the aircraft impacted the ground almost vertically. The pilot sustained serious head injuries, and did not survive.

The witnesses' descriptions suggest that the pilot had deliberately initiated a low-level turn shortly after takeoff with the intention of flying directly over them. It was likely that the pilot was focussed on the low-level flight over his friends and anticipated a pull-up manoeuvre to avoid the trees behind the hangars but subsequently forgot about the powerlines.

Flying at low level gives very little or no margin to recover from unexpected events, such as aerodynamic stalls or engine failures.
