**ATSB TRANSPORT SAFETY REPORT**

Aviation Research and Analysis - AR-2009-041

**Avoidable Accidents No. 1**

# **Low-level flying**

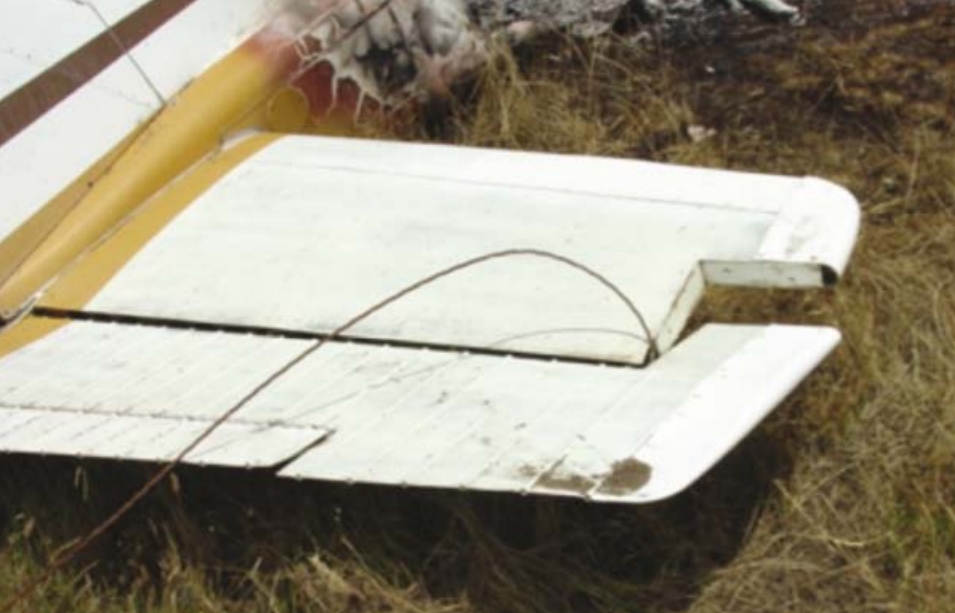
*Section of the struck powerline caught in the horizontal stabiliser*

The aircraft had hit powerlines after flying over the house. The powerlines were only 86 ft (26 m) above the ground. Since the pilot was familiar with the area around the property, he was probably aware of the location of the powerlines. However, powerlines are naturally difficult to see. Normal powerlines are not required to be marked for aviation and are usually unmarked, as was the case in this accident.

*Just because you know the area and the associated wires, doesn't mean you will always avoid powerlines and other hazards of flying at low level. It only takes a minor distraction to draw your attention from a vigilant lookout. If there is no reason to fly below 500 ft – then don't.*

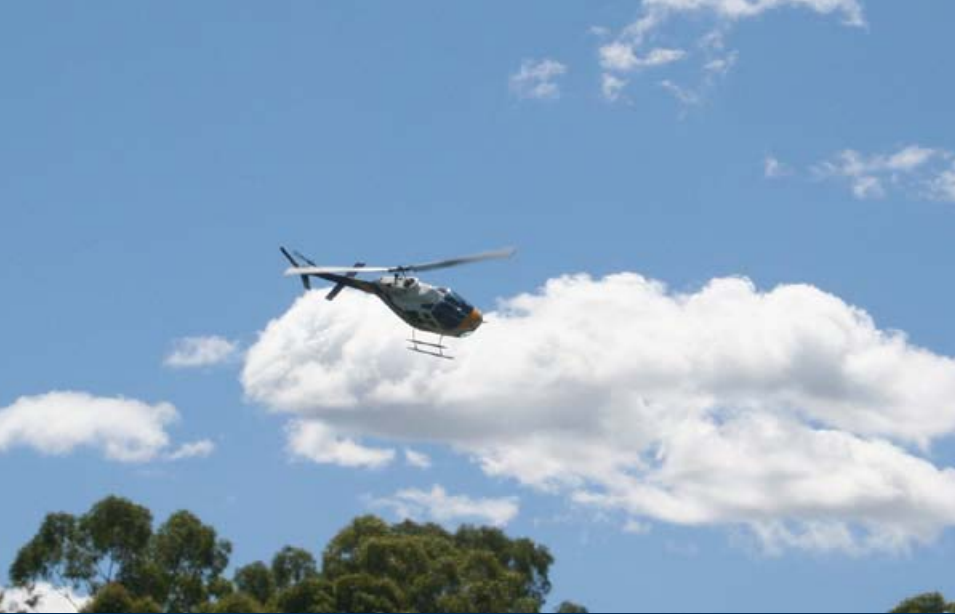
*The helicopter during a turn*

Witnesses reported that the helicopter was making low-level passes, about 100 ft above the ground, over the property. After one of the low passes, the helicopter banked steeply to the left, rolled out and descended. As the helicopter was being operated at a height at which recovery was not possible, it impacted surrounding trees. The helicopter was severely damaged and broke into several parts on impact.

*The pilot would have had more time to assess and react to the loss of control situation had he operated the helicopter at the manufacturer's weight limitations and at 500 ft or more above ground level in accordance to civil aviation regulations.*

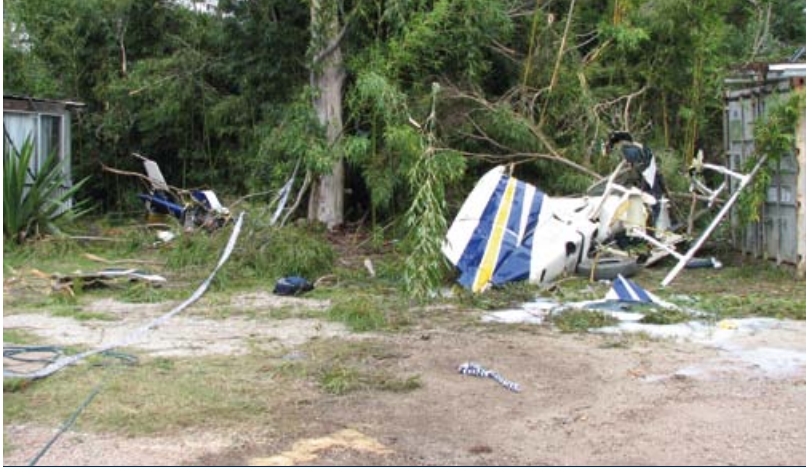
Main wreckage

The helicopter had been maintained and inspected appropriately and no mechanical defects were found that would have affected the safe flight of the helicopter. However, it was found that the helicopter was 28 kg over its maximum take-off weight (MTOW) limit at the time of the accident. One of the passengers confirmed they were not weighed prior to departing Bankstown airport.

*In addition, the injuries to the occupants may have been reduced if all had been wearing their seat belts.*

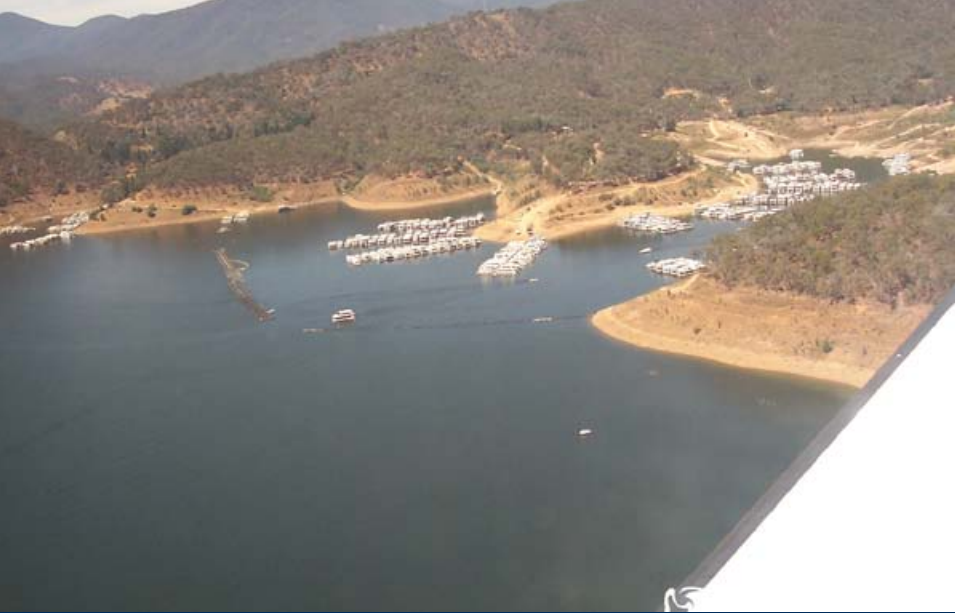
*Lake Eildon, Victoria*

The Piper PA-28 Cherokee Arrow aircraft struck high-voltage powerlines suspended over the lake. The aircraft was destroyed by the impact with the wire and with the water. All three passengers were fatally injured and the pilot's body could not be found.

The power line involved in the accident spanned a 2 km length across Lake Eildon. The aircraft struck the power cable at the lowest point of the span, which was only 133 ft above the water. Under relevant Australian Standards, the power line was not required to be fitted with marker devices as it was less than 295 ft (90 m) in height.

*Do not rely on marker devices to alert you to the presence of powerlines. Powerlines under 295 ft (90 m) in height, as was the case in this accident, are not required under Australian Standards to be fitted with marker devices.*

*Familiarise yourself with the location of power lines by studying maps of the area before flight.*

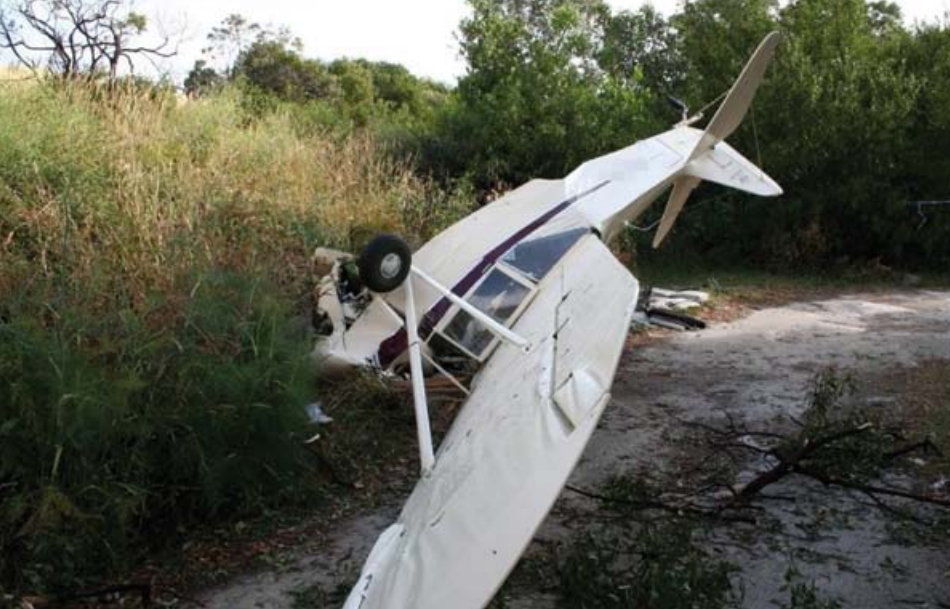
*Wreckage of the Auster-J1B*

As the aircraft approached the hangars, it climbed suddenly and hit powerlines that passed across the gap between the hangars. Investigation of the wreckage found that the aircraft propeller took the full force of the wirestrike, causing the propeller to disintegrate and the engine to stop. The aircraft aerodynamically stalled at a low altitude, possibly due to the pilot's attempt to avoid trees directly behind the powerlines. Due to the pilot's low altitude, he had little margin to recover from the stall, and the aircraft impacted the ground almost vertically. The pilot sustained serious head injuries, and did not survive.

*Flying at low level gives very little or no margin to recover from unexpected events, such as aerodynamic stalls or engine failures.*

*This accident also illustrates that pilot awareness of powerlines while on the ground doesn't always equate to awareness of them whilst in the air. Powerlines are difficult to see as they can blend in with the background vegetation or the sky and this is especially true while flying at low level.*

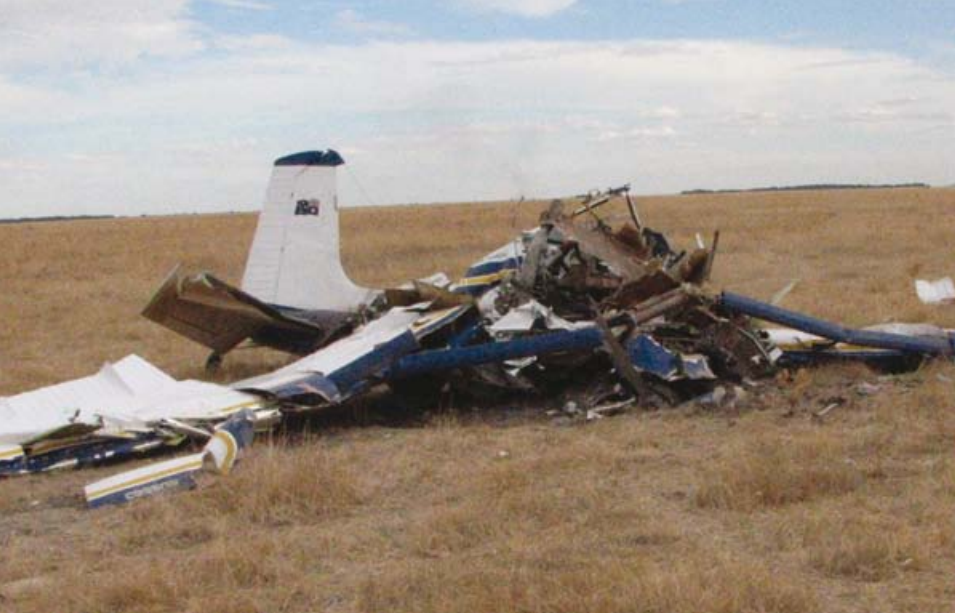
*Wreckage of the Cessna 188B Agwagon*

In March 2006, the wreckage of a Cessna 188B Agwagon was found in a paddock near Narrandera, New South Wales. The wreckage showed that the aircraft hit the ground heavily, in a nose-down, right wing low position. The pilot was fatally injured. There were no powerlines or other obstacles in the area near the accident site which may have contributed to the accident.

*This accident serves as a salient reminder of the dangers of conducting unauthorised low-flying activities and aerobatic manoeuvres if you are not approved to do so and/or in an aircraft for which those manoeuvres are prohibited.*

*If you are a pilot and you witness unsafe flying, use your influence to discourage it, and if necessary report it – you may never get a chance later.*

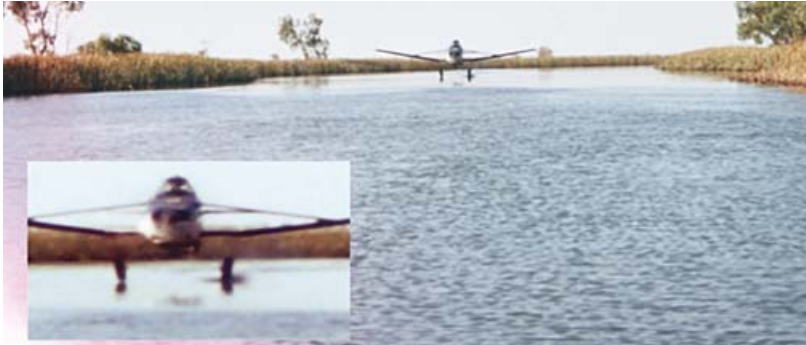
Although there were no witnesses to the accident itself, a number of people witnessed the pilot's flying activities prior to the accident. The pilot had landed in a paddock adjacent to a water-skiing area on a local river, where a large group of local people had gathered and a number of ski boats were operating. The pilot announced an intention to do some low passes over the water-ski area. Before taking off for those low passes, the pilot handed his camera to a friend (also a pilot) so he could take pictures of him flying over the water-ski site. After making four very low passes, the pilot landed in the paddock and retrieved his camera. One of the recovered camera images showed the aircraft's main wheel touching the surface of the water during at least one of the low passes.

*Images from the pilot's camera of the day's flying activities*
