**ATSB TRANSPORT SAFETY INVESTIGATION REPORT**

Technical Analysis Occurrence Report – 200601173

**Microlight Structural Analysis**  
**Airborne Edge**  
**Aircraft Registration: 32-4456 and 32-4388**

Microlight Structural Analysis, Airborne Edge, Aircraft Registration: 32-4456 and 32-4388

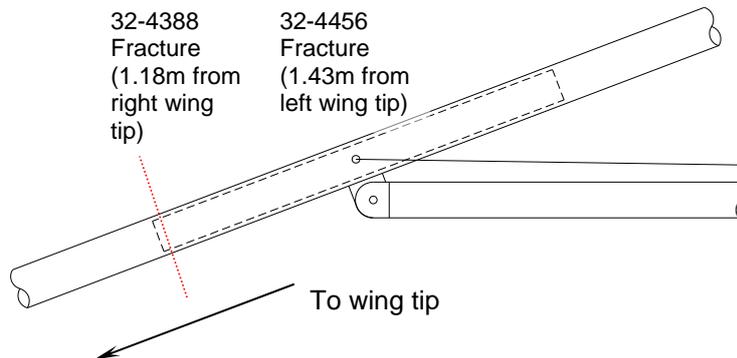
The left and right rear leading-edge wingspar (Streak 1 airframe) for 32-4456 were received and examined. The spar tube (tip) had a wall thickness of 1.2 mm and the location of fracture of the left spar was 1.43 m from the left wing tip, see figure 3. The fracture occurred transversely through the tubular section, at the insertion of the reinforcing sleeve. The fracture site showed typical characteristics of bending (i.e. the thin-walled tubular section had collapsed) with evidence of tearing of the aluminium tube, see figure 4. The concave surface of the collapsed section was located on the underside of the spar, indicating a downward bending load (normal to the plane of the wing). There was no evidence of defects or pre-existing cracks that could have contributed to the failure of this component.

**Figure 3: Location of the fractures fore 32-4456 and 32-4388. Note: both occurred through the outer end of the internal reinforcing sleeve. Diagram not to scale.**

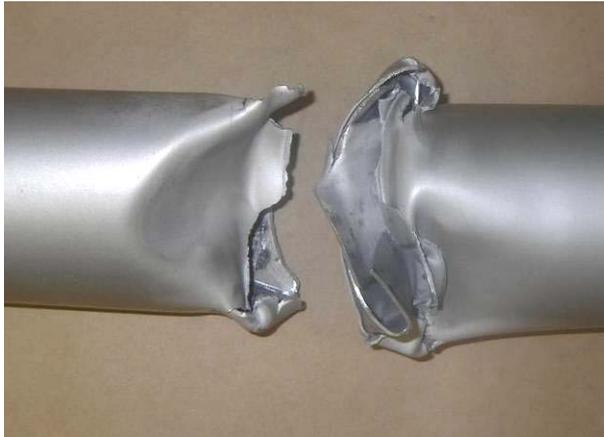
**Figure 4: Fracture of the left wingspar of 32-4456.**

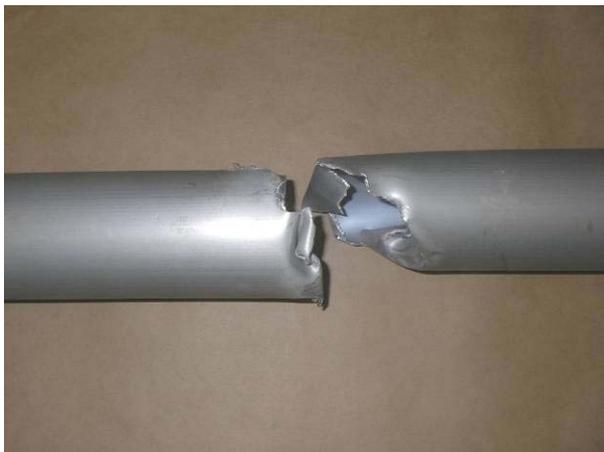
Examination of the fractured right wing spar from 32-4388 (Streak 3 airframe) showed similar fracture characteristics to 32-4456. The fracture occurred 1.18 m from the right wing tip, at the outer end of the internal reinforcing sleeve, and evidence of bending and tearing of the tubular section was observed, see figure 5. Unlike the fracture of 32-4456, the fracture surface was angled, indicating a downward bending load (normal to the plane of the wing) and rearward load (i.e. parallel to the plane of the wing). Small dents in the wingspar were observed along its length. There was no evidence of pre-existing defects or prior cracks that could have contributed to the failure of this component.

**Figure 5: Fractured right wing spar of 32-4388. Note buckling and tearing features of the fracture and the 'slant' of the fracture.**

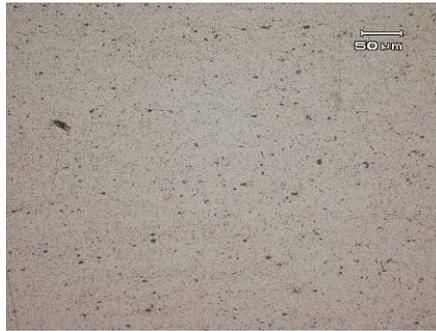
The microstructure, see figure 8, of all three samples included elongated grains, containing small, black, evenly dispersed particles suspected to be Magnesium Silicide ( $Mg_2Si$ ).

**Figure 8: Microstructure of sample 3. Similar characteristics were observed for samples 1 and 2.**

Five Vickers hardness tests were completed for each of the three samples. Hardness ranged between 98HV<sub>5</sub> and 104HV<sub>5</sub> (average 101HV<sub>5</sub>). This was typical for Aluminium alloy 6061-T6<sup>4</sup>.

The microstructure and hardness results for all three samples taken from the leading-edge wingspars of 32-4456 and 32-4388, were consistent with an Aluminium alloy 6016-T6. They were within the manufacturer's material specifications and there was no evidence of material deficiencies or abnormalities that could have contributed to the failure of the wingspars.

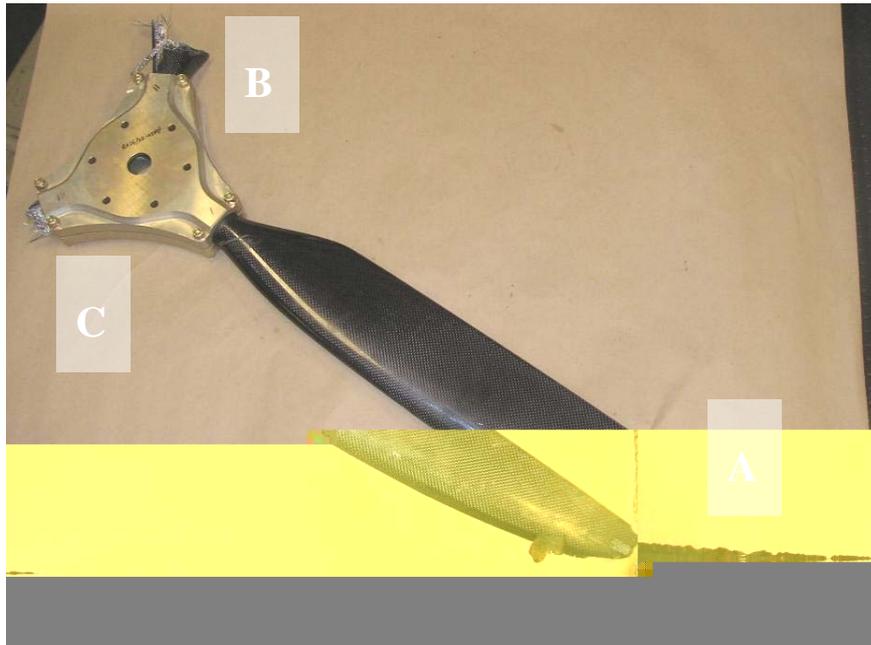
The propeller from 32-4388 is shown in figure 9 in its as-received condition. The propeller assembly was identified as a Carbon Fibre- Epoxy, three-blade construction with an aluminium alloy hub. The blades consisted of a glass fibre-epoxy and foam core, with a carbon fibre-epoxy outer surface<sup>5</sup>. For analysis purposes, the three blades were labelled A, B and C, see figure 9. All three blades were able to be rotated within the hub assembly.

**Figure 9: Fractured propeller from 32-4388.**

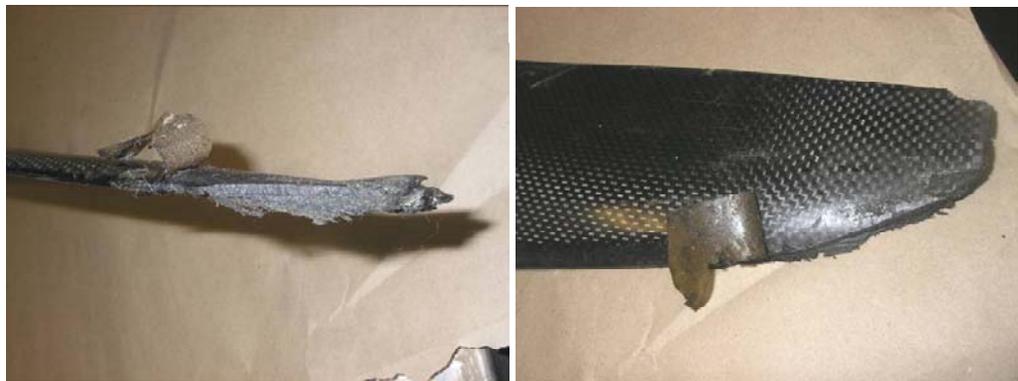
Examination of blade A, the only intact blade, revealed leading edge damage, see figure 10. The damage was predominantly at the tip of the blade and included splitting of the carbon fibre surface and de-bonding of the outer coating. There was no observed fibre pull out at this location.

**Figure 10: Leading edge damage to blade A.**

Damage to the tip of blade A from microlight 32-4388 was consistent with being involved in an impact event. Failure of blades B and C were consistent with bending overload failure. Both blades exhibited fibre pullout which was longer on one side of the fracture to the other, suggesting failure under directional bending load. Damage to blade B was consistent with a bending load applied in the direction of rotation, however this could not be established for blade C, as the blade had moved within the hub. It is likely that such loading occurred during an impact event. There was no evidence of mechanical or material defects that could have contributed to the premature failure of the propeller.

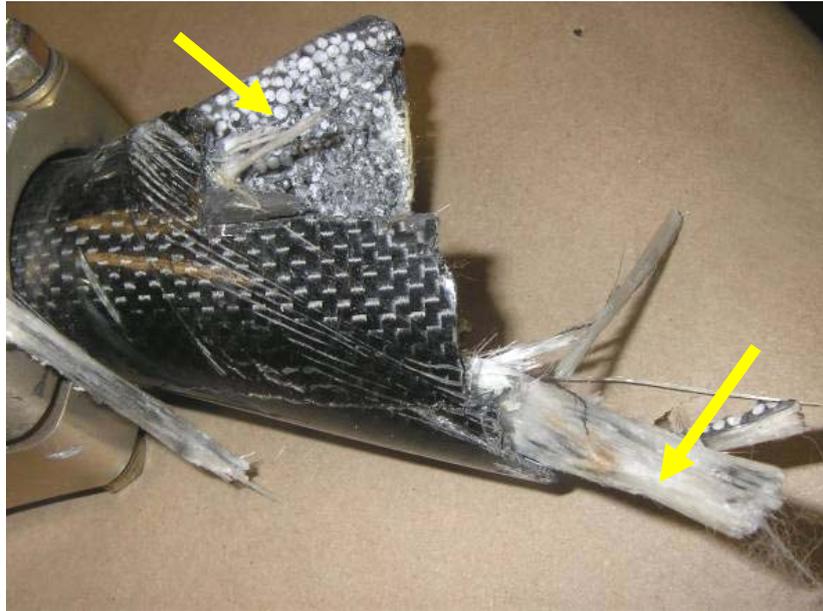
Blade B included a stepped fracture surface and glass fibre pull out was observed. The pull out was longer on one side of the fracture than the other, arrowed in figure 11. The fracture characteristics of the foam core showed two distinct fracture regions, a smooth region and a coarse region.

**Figure 11: Fracture surface of blade B. Note that fibre pull out is longer on one side of the fracture (arrowed).**

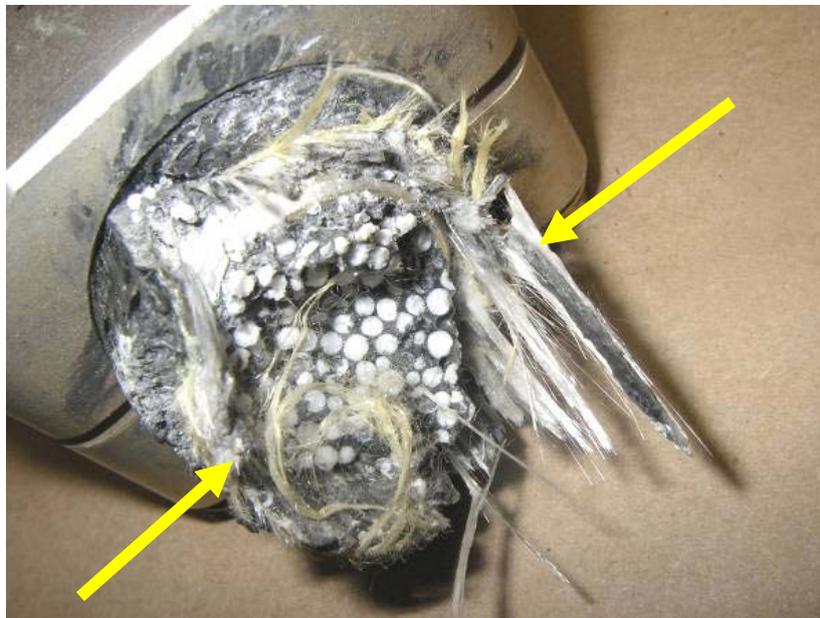
The fracture of blade C was close to the propeller hub and was relatively flat, the inner metal core was visible and glass fibre pull out was observed. Similar to blade B, fibre pull out was longer on one side of the fracture than the other, arrowed in figure 12.

**Figure 12: Fracture surface of blade C. Note fibre pull out was more pronounced on one side of the fracture surface (arrowed).**

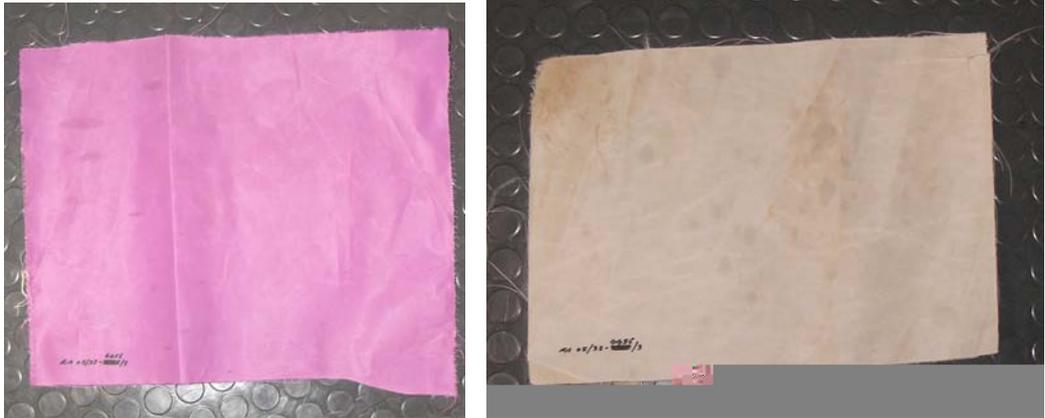
Two sections had been taken from the 32-4456 microlight canopy for analysis, see figure 13; a sample of the leading-edge fabric (purple), and a sample from the top surface of the wing, back from the leading edge to the trailing edge (off-white). The purple sample was relatively unsoiled, while the off-white fabric sample included a number of unidentified stains.

**Figure 13: Purple and off-white fabric sample taken from the microlight canopy.**

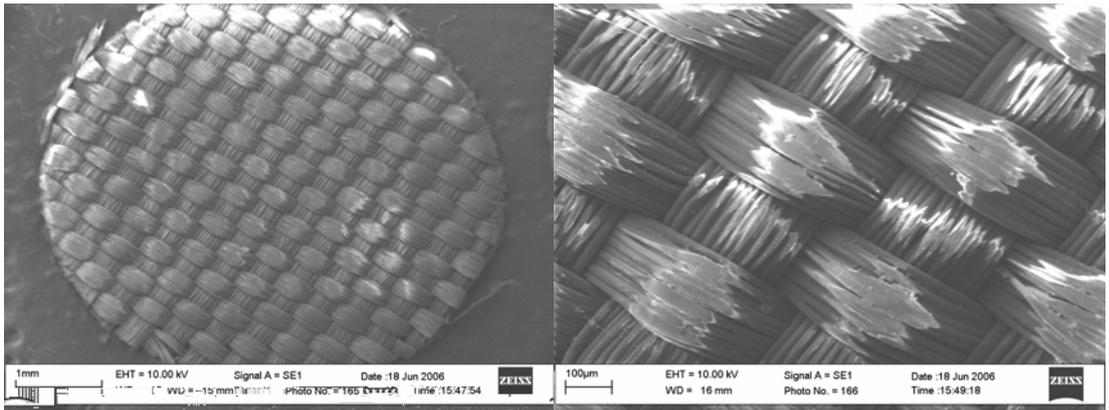
Examination of the purple fabric samples, see figure 14, revealed intact, undamaged threads, with no visual evidence of degradation. Examination of the off-white fabric samples showed irregularities in the weave and contamination of the threads, arrowed in figure 15. Those samples were viewed under the light microscope, and areas of damage coincided with stains on the fabric.

**Figure 14: Thread condition characteristic of the purple fabric sample at high and low magnifications.**

Visual examination of the canopy material from microlight 32-4456 showed no evidence of gross abnormalities. The samples representative of the purple fabric section of the microlight canopy were in good condition. Threads were observed to be intact and the weave was regular. The samples representative of the off-white fabric section of the canopy exhibited some irregularities in the weave and damaged threads. These corresponded to stains observed on the fabric. It is likely that these threads were damaged during impact, as dirt was encrusted onto the fabric.

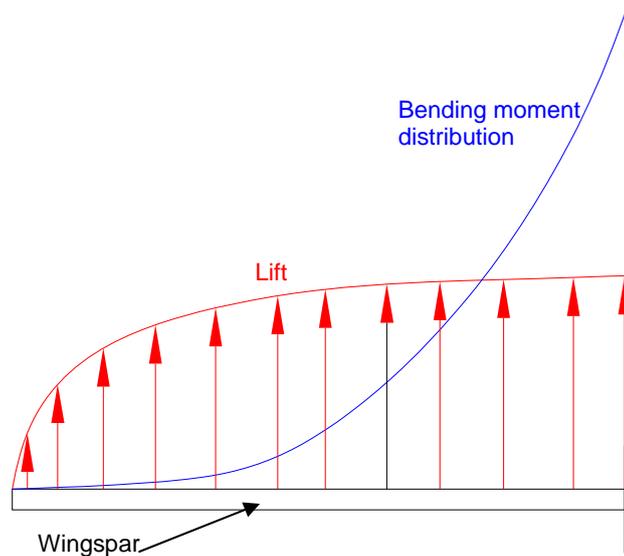
Review of the Airborne Edge microlight structure indicated that the section of leading-edge beam, outboard of the outer most bracing wire, would effectively act as a cantilever. Figure 16 presents bending moment distribution of a cantilever under this type of loading. The maximum bending moment would occur at the bracing-wire attachment, however the internal reinforcing sleeve would provide a significant amount of support to the beam and thus it is likely in overload conditions that the failure would occur in the main tube at the end of the sleeve, as observed.

**Figure 16: Bending moment distribution on a cantilever representation of the wingspar**
