ATSB TRANSPORT SAFETY INVESTIGATION REPORT

Aviation Occurrence Report – 200601688

Engine power loss – Bankstown Airport – 5 April 2006

Amateur-built Lancair 360

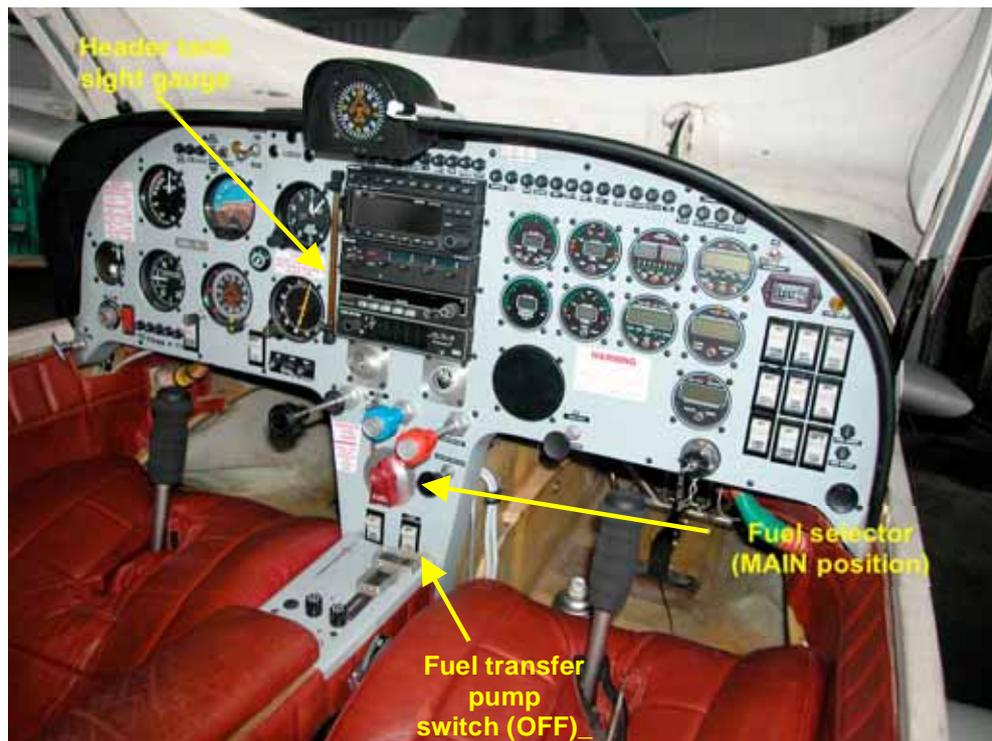
Figure 5: Aircraft cockpit and instrument panel (14 March 2006)

The builder modified the standard fuel system by incorporating a fuel selector (figure 5) and fuel lines that allowed the engine to be supplied directly from the header tank or either wing tank. An electric pump and fuel lines were also fitted to allow transfer of fuel from the left wing tank to the header tank. The header tank had a maximum capacity of 41 L and each wing tank had a maximum capacity of 80 L.

The POH/AFM fuel management information and instrument panel placard did not apply to the system in VH-ZNZ because fuel was not supplied solely from the header tank.

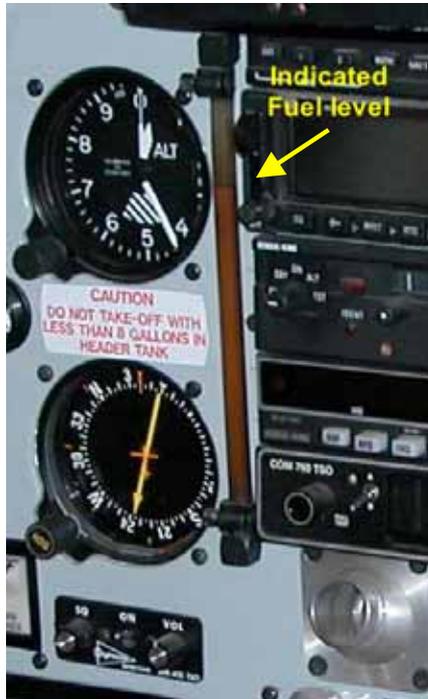
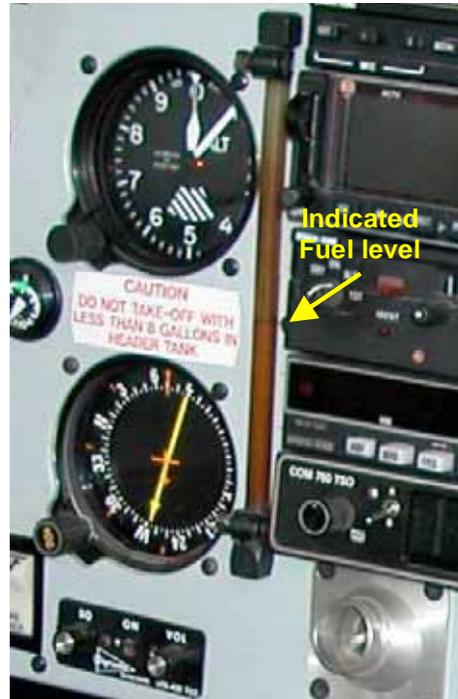
Figure 6: Header tank quantity indications

There was no reliable evidence of tank selection or header tank quantity after 14 March 2006. Although there were reports of engine ground running after that date, the reports were not detailed or consistent. As a result, the investigation was unable to accurately determine the quantity of fuel consumed since 14 March 2006.
