Aviation Occurrence Investigation – AO-2007-029

In-flight break-up – Clonbinane, Vic. – 31 July 2007

VH-YJB

Rockwell Commander 500S

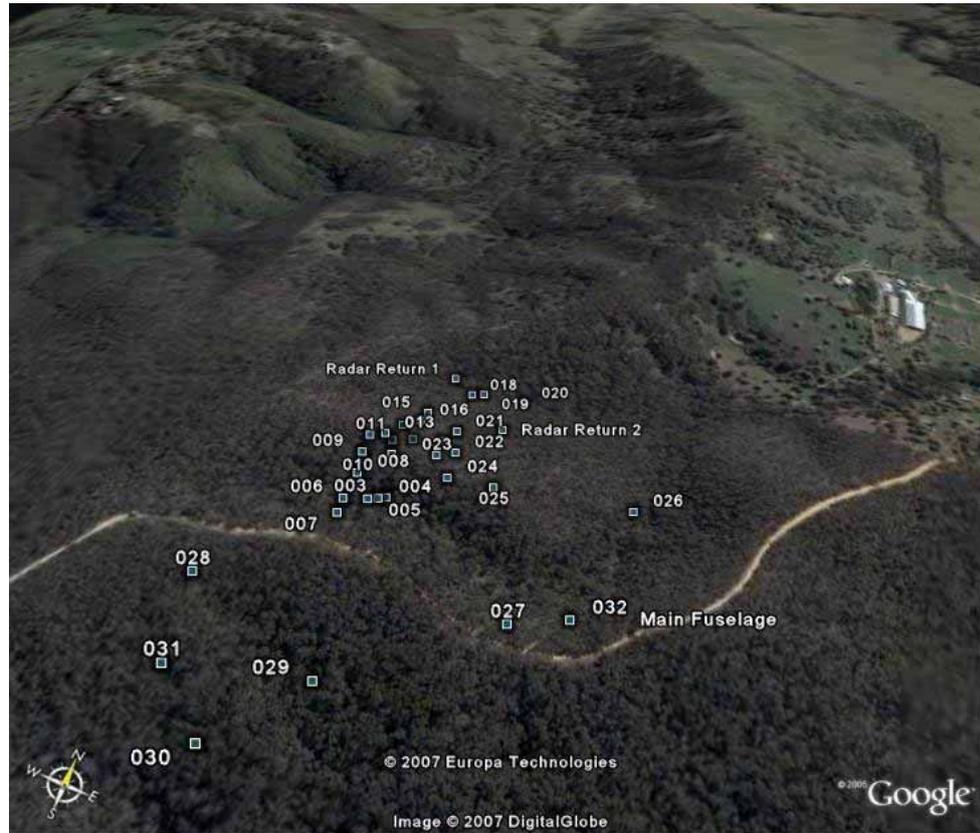
Figure 1: Accident site, showing the distribution of the wreckage and the position of the last two radar returns

The main section of wreckage was located at 37° 21 39'S, 145° 05 92'E in timbered, hilly terrain at an elevation of approximately 1,400 ft (Figure 1). The accident was not survivable. The main section of wreckage had descended almost vertically through the tree canopy and impacted the sloping ground in a flat, inverted attitude (Figure 2). There was no fire. The outboard section of both wings from approximately the aileron/flap junction, the rear fuselage, tail cone and empennage, and the aft cargo door had separated from the aircraft and were later located north and west of the main wreckage at distances up to 700 m. The wreckage distribution was consistent with the aircraft having broken up in flight, prior to impacting the terrain.

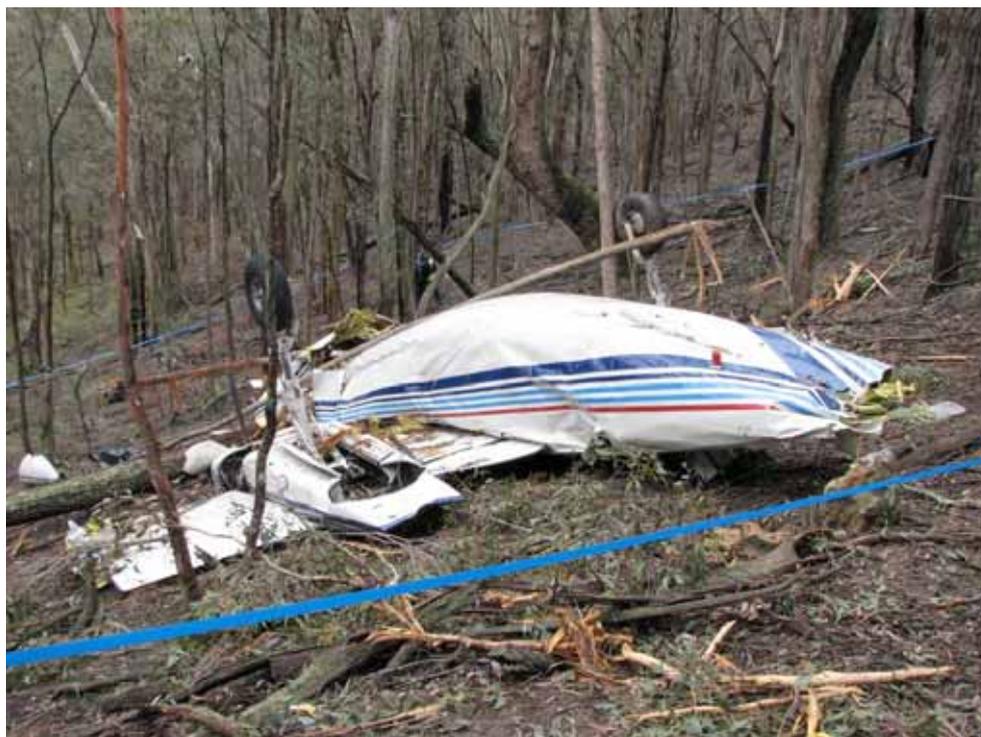
Figure 2: Main section of wreckage

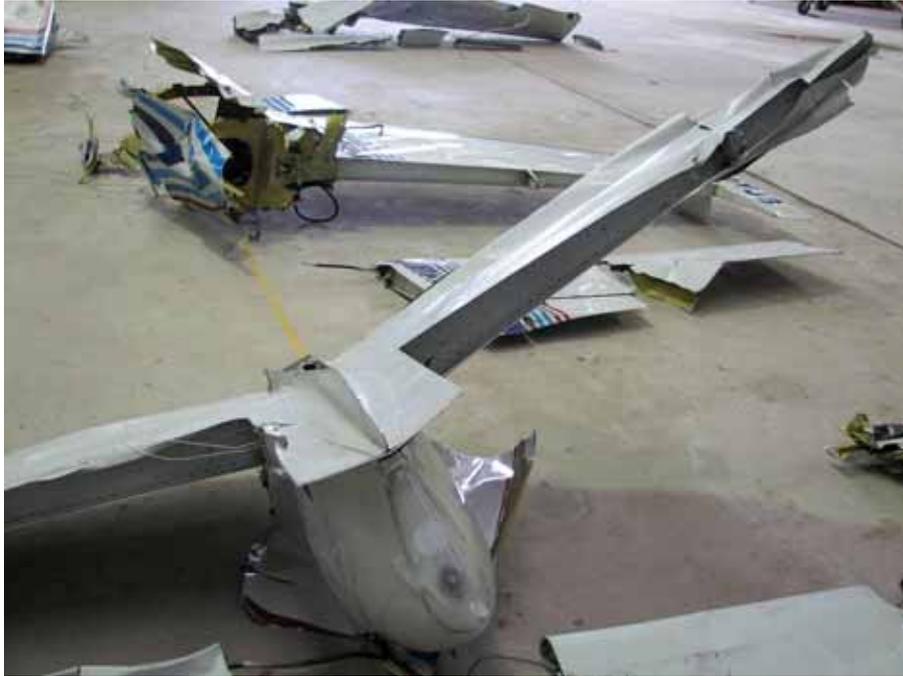
Thirty-two discrete airframe sections and components were recovered from the accident site and transported to a covered facility for detailed examination (Figure 3). Those components included the two outer wing sections and ailerons, the empennage including tailplanes and control surfaces, the left engine nacelle rear fairing and the rear cargo compartment door.

Figure 3: Part of the wreckage reconstruction

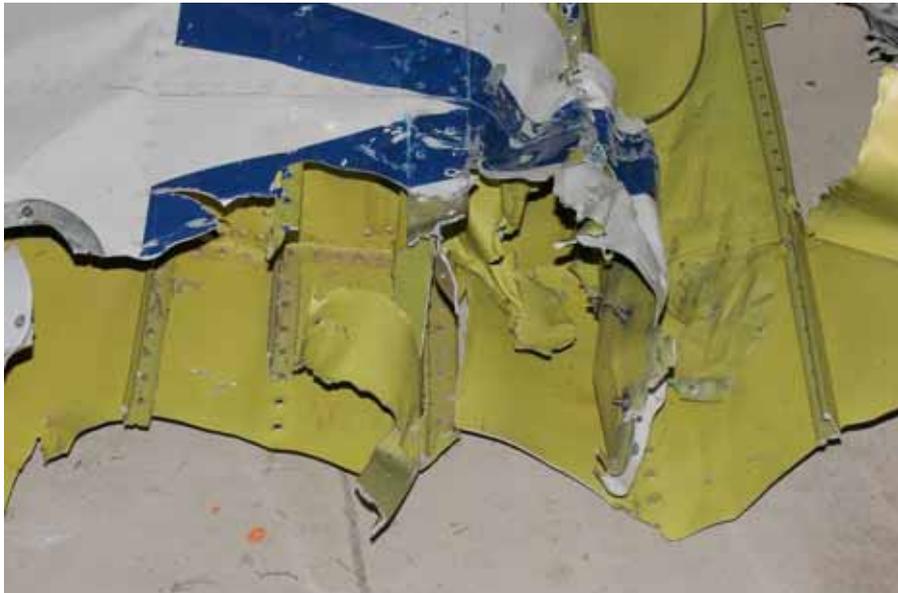
Both left and right outer wings had separated from the airframe at symmetric locations, coincident with the outboard flap / aileron transition. There were comparable levels of mechanical deformation of the upper and lower main spar elements (Figures 4 and 5) at the point of separation, consistent with the failure of both outer wing sections under downward bending loads. Similar downward bending characteristics were also exhibited by the wing rear spar elements.

Figure 4: View of the left wing main spar and surrounding fractures

None of the failed wing main structural load-bearing elements showed any evidence of cracking, corrosion or other pre-existing defects. All fracture features were typical of ductile tensile or shear failure under elevated stresses.

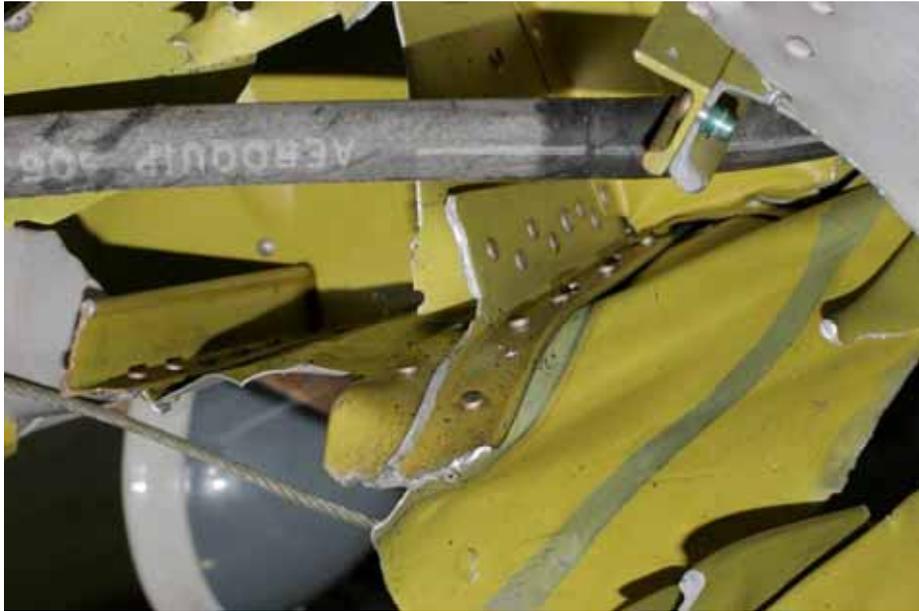
Figure 5: View of the right wing lower spar cap fracture surfaces
