Federal Aviation  
Administration

**ALAC CATERGAL AIRPLANE  
SPECIAL REVIEW TEAM REPORT  
MAY 2010**

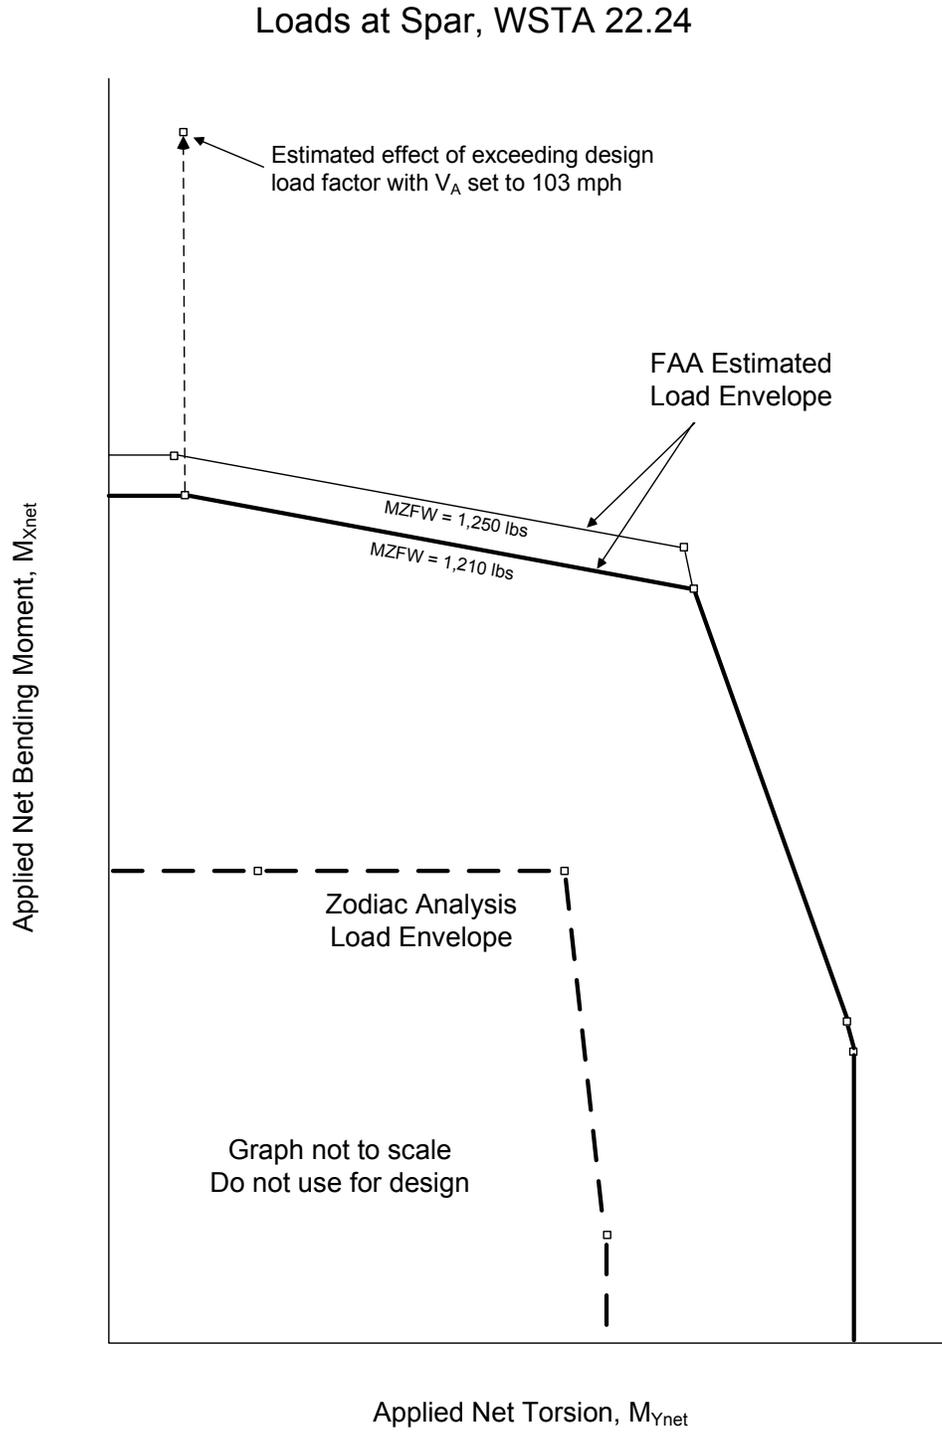
**Figure 1: Comparison of FAA Estimated Loads with 'Zodiac CH 601 XL Stress Analysis and Tests'**

- The amount of lift produced by the portion of the wing planform covered by the fuselage. The manufacturer’s analysis assumes the wing planform covered by the fuselage is as effective in producing lift as an adjacent portion of exposed wing planform. This assumption may not be conservative and may be noncompliant with the ASTM F 2245 § 5.1.1.2 requirement that ‘...these loads must be distributed to conservatively approximate or closely represent actual conditions.’

- The correct definition of the maximum zero fuel weight (MZFW). The manufacturer’s analysis defines the MZFW as the maximum takeoff weight (MTOW) minus full fuel. This definition is incorrect. The intent of the MZFW is to design the wing for the condition where airplane weight is at a maximum but the wing fuel tanks are only partially full. Because the fuel load is alleviating for wing bending loads, using the proper fuel load to determine MZFW is important.

For the CH 601 XL, the MZFW case is the condition where two occupants (190 lbs each, according the ASTM standard) are added to the empty weight of the airplane (830 lbs). Then sufficient fuel is added to the wing tanks to reach MTOW. For the CH 601 XL, the MZFW is 1,210 lbs (830 + 380 lbs) and the MTOW is reached with 110 lbs of fuel, instead of the zero fuel weight used in the manufacturer's calculations. This could lead to the structure being designed to a lower capacity than needed.

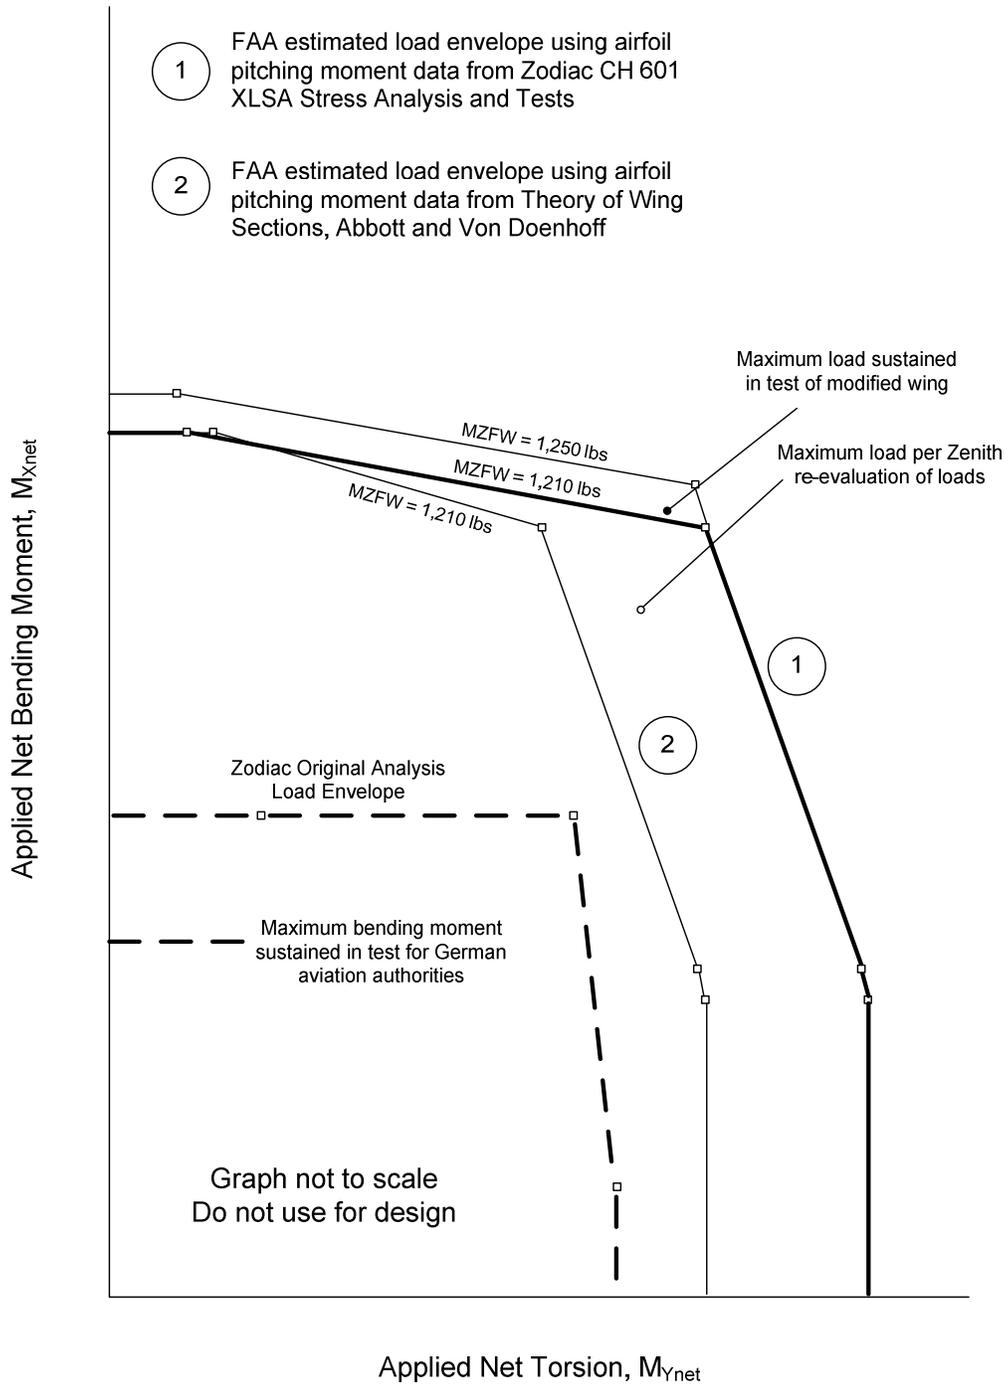
**Figure 3: Revised Zodiac Analysis and Static Test Wing Design Loads**

The manufacturer successfully tested the modified wing structure to loads higher than determined in their revised analysis. The wing structure did not fail at the ultimate test loads. However, the wing attachment bolts were bent and the attachment bolt holes were elongated, indicating there was permanent damage to the structure at these loads. We have depicted the loads from the manufacturer's revised analysis and static test in figure 3.

Despite disagreeing with our position on several significant issues, the maximum bending moment achieved in the static test is only a few percent below our estimated maximum required bending moment. The maximum torsion load achieved in the test may only be a few percent below our estimated maximum torsion provided the manufacturer can justify the airfoil pitching moment data with applicable test data. It is possible that if the manufacturer had continued the static test to structural failure, the ultimate test load could have equaled or exceeded FAA estimates of the required load envelope.

- The manufacturer stopped the static test of the modified structure approximately five percent below the FAA’s load estimates required for ASTM compliance. At the time of this report, the manufacturer was continuing to make modifications to the wing structure and the drawings referenced by the safety directive to provide further improvements. The manufacturer should consider additional structural testing and analysis once a final design is reached to demonstrate the new wing meets the ASTM standards.

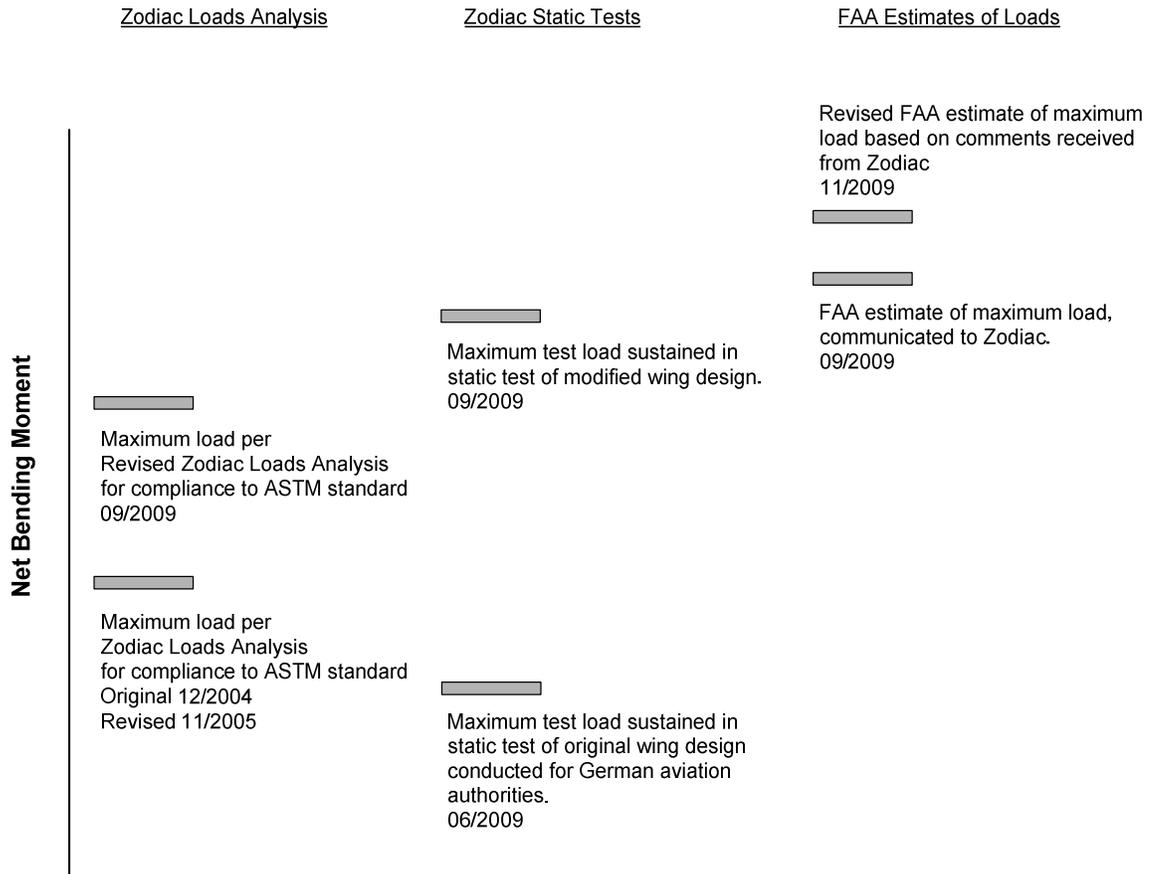
**Figure 4: History of Zodiac Wing Structural Loads Analysis and Tests**

Figure 4 presents a history of the manufacturer's loads analysis and static testing. We provide this information to provide a time line of the manufacturer's structural analysis and testing.

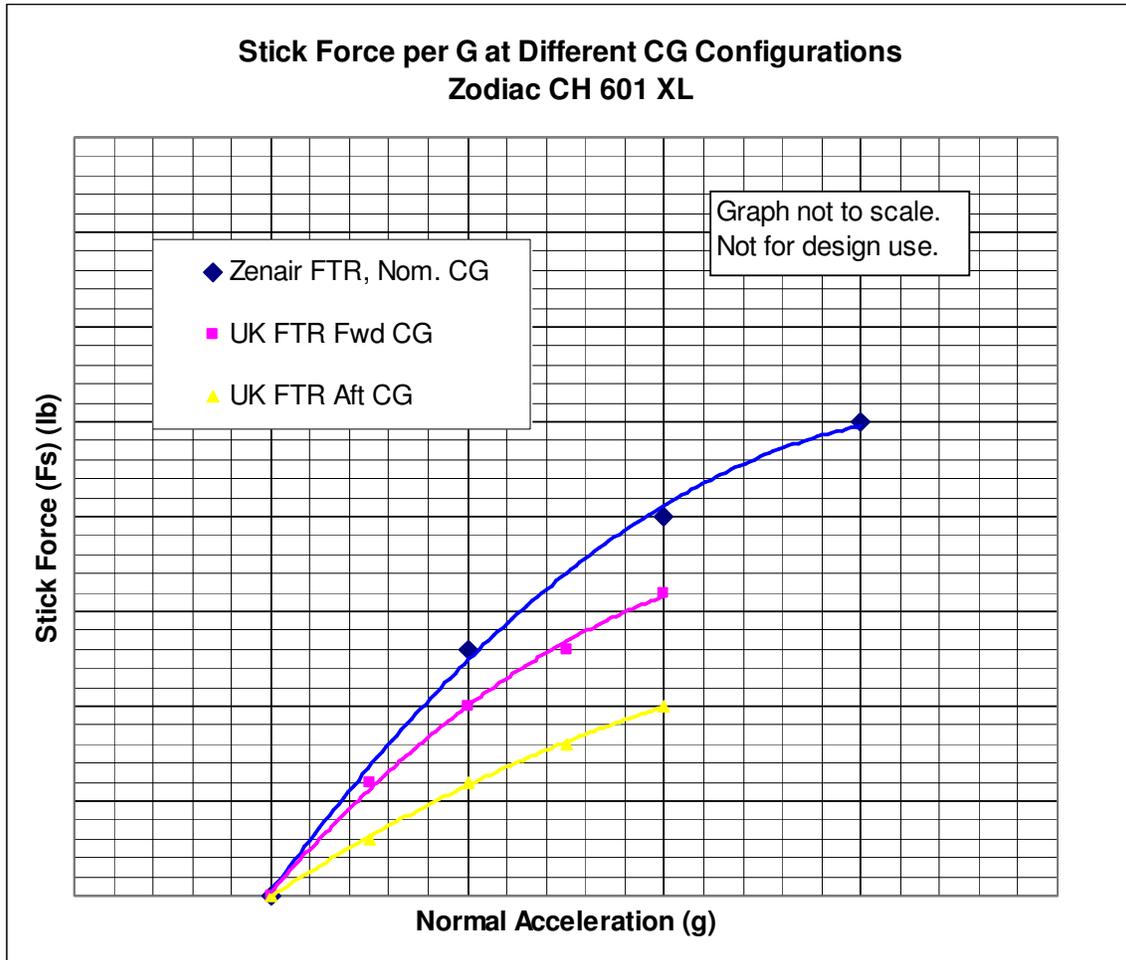
Figure 5: CH 601 XL Stick Force per g Evaluation

Though not required to do so, it appears their tests followed the guidance provided by AC 23-8B. However, when applying this guidance to aft center of gravity data to match compliance with 14 CFR Part 23 § 23.155(a), Figure 5 shows the stick force at limit load appears to extrapolate to a value slightly less than the 15 pound minimum requirement at limit load. Though the CH 601 XL does not have to comply with 14 CFR Part 23, the data does indicate that stick force gradients may not be acceptable for aircraft that are intentionally or unintentionally flown outside the POH center of gravity limits. This is simply presented for regulatory comparison, as 14 CFR Part 23 § 23.155(a) is not currently reflected in the ASTM standards at any center of gravity configuration.

- The current ASTM Standard F2245, 4.5.2.2 is actually more stringent than its 14 CFR Part 23 § 23.155(c) counterpart and may remain unchanged.
- The ASTM standard does not currently require a minimum control force at the limit load factor. ASTM International should amend their standards to require a minimum control force at limit load factor, similar to concepts defined in 14 CFR Part 23 § 23.155(a).

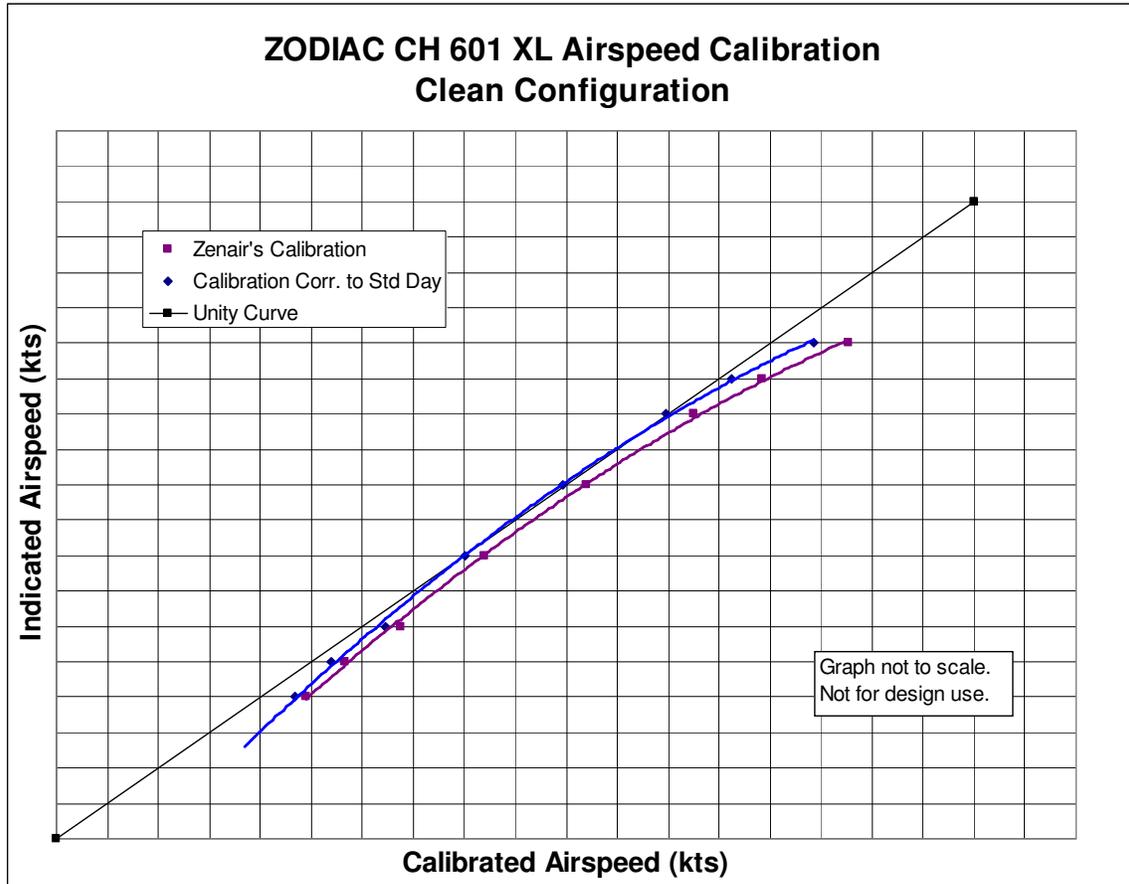
Figure 6: Standard Day Correction Effects on CH 601 XL Airspeed Calibration

Regarding stall speed, the manufacturer's flight test report determined the flaps up stall speed to be 35 knots indicated airspeed (KIAS) (40 mph) which was reported as 43 knots calibrated airspeed (KCAS) (50 mph). In reality, it was 43 knots true airspeed (KTAS) (49 mph), which after correcting to standard day conditions; the stall speed is calculated to be 41 KCAS (47 mph). The manufacturer's Airplane Flight Manual (AFM) reported a 43 knot (49 mph) flaps up stall speed indicating that standard day corrections were not applied to the flight test data.

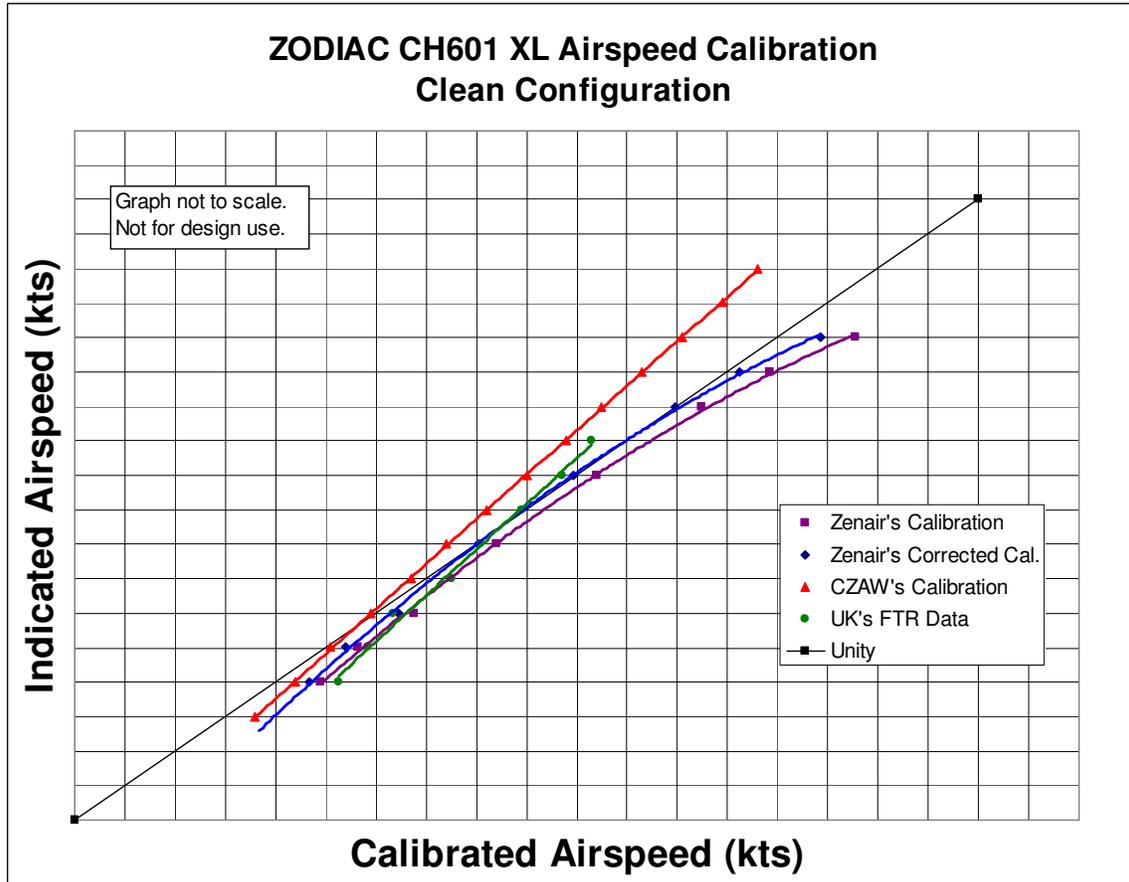
Figure 7: Zodiac CH 601 XL Airspeed Calibration Comparison

A comparison was made between CZAW and the manufacturer's airspeed calibrations. The calibrations were substantially different in both shape and magnitude. Without the flight test report, it is impossible to say which calibration is correct assuming that both designs are identical. Therefore, the potential to overspeed the aircraft exists. However, as part of the UK LAA flutter mitigation flight test program, an airspeed calibration was conducted and the results were overlaid with those from the manufacturer and CZAW, as seen in Figure 7. (Note: We have removed the actual airspeed values from figures 6 through 8 to protect the manufacturer's proprietary information and data.)

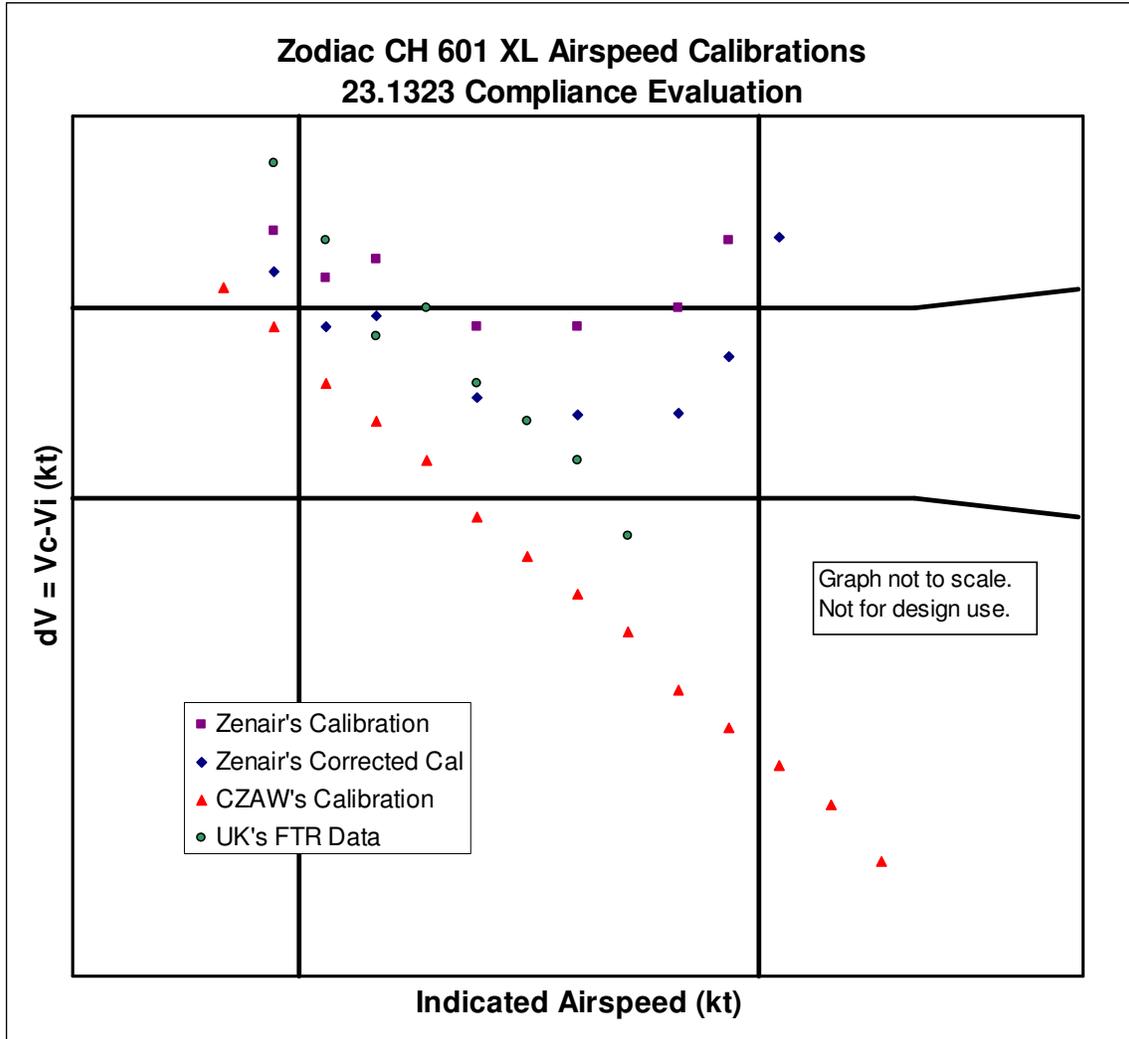
**Figure 8: Zodiac Airspeed Calibration Evaluation per 14 CFR Part 23 § 23.1323(b)**

The UK LAA's flight test results are similar in magnitude to the manufacturer's data, but trend with CZAW's data making the comparison inconclusive. Using a different approach to determine the validity of the calibration data, a 14 CFR Part 23 § 23.1323(b) analysis was performed on these data sets and shown graphically in Figure 8. It should be

To evaluate the airspeed error per 14 CFR Part 23 § 23.1323(b), the error  $dV$ , must be less than  $\pm 5$  knots or 3% bounded by a lower airspeed of  $1.3V_{S1}$  to a maximum airspeed of  $V_{NE}$ . Using the manufacturer's values, this means that to meet 14 CFR Part 23 § 23.1323(b), all the applicable data needs to fall in the enclosed  $\pm 5$  knot rectangle.

With these criteria in mind, the manufacturer's original calibration did not meet 14 CFR Part 23 § 23.1323 until after correcting for standard day temperature conditions. For comparison, neither CZAW nor the UK LAA's data meets 14 CFR Part 23 § 23.1323, though they are not required to do so. However it is unusual for a low speed aircraft like the CH 601 XL to need a -24 knot static source error correction, indicating a potential error in the calibration methods used. If corrected improperly, this large airspeed error could translate into approximately a 2.8g load difference at maneuver speed for the CH 601 XL and CH 650. This evaluation suggests the need for an ASTM standard similar to
