THE AERO COMMANDER CHRONICLE

S.J. Swift¹

The service history of the Aero Commander light twins teaches a hard lesson in the theory and practice of fatigue control.

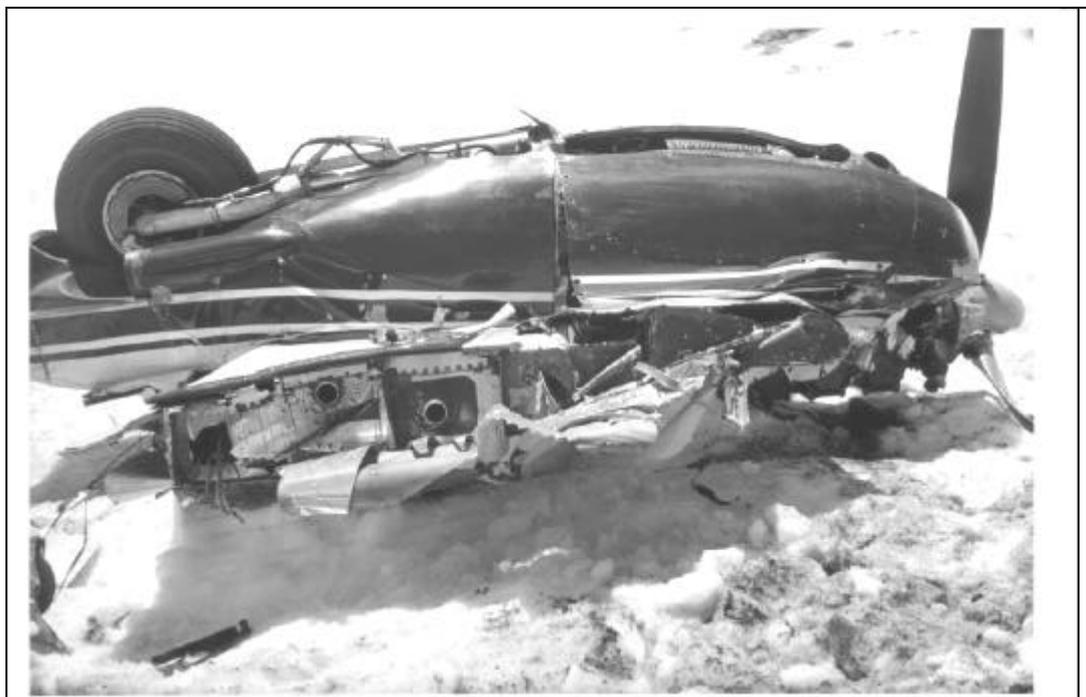
Wing separation, New Zealand 1961

| November 1961 | Aero Commander 680 ZK-BWA crashed in New Zealand. The wing main spar lower cap failed by fatigue at wing station (WS) 24 after 5040 flight hours. |

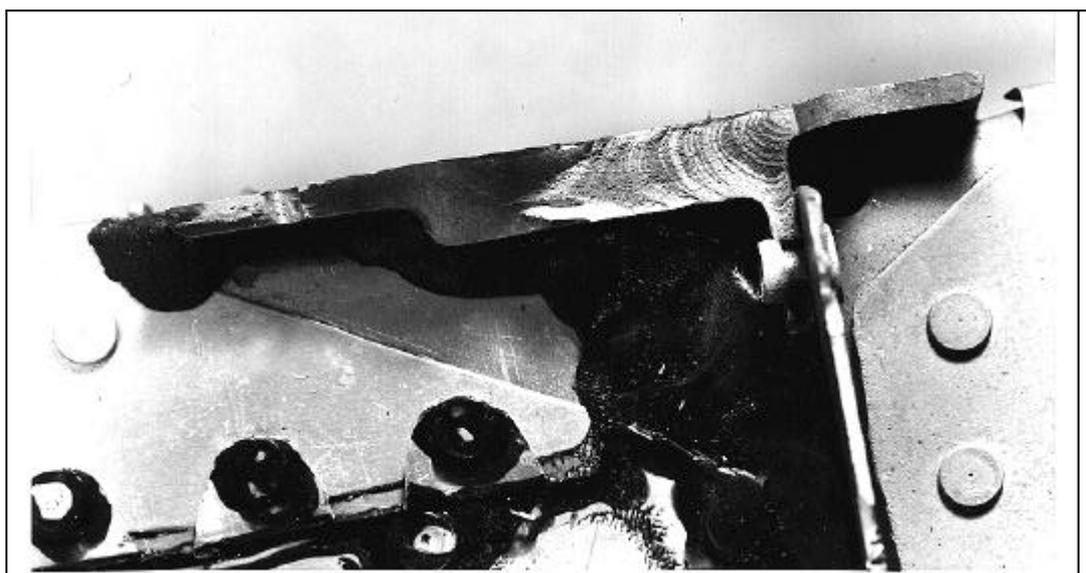
Most of the problems have centred on the bend in the main spar lower cap, where the highest flight stresses coincide with high residual stresses and a geometric discontinuity - at wing station (WS) 24 for short wings and WS 39 for long wings.

Main spar lower cap at Wing Station 24 failure site

A fatal wing separation in New Zealand in 1961, another in Canada in 1964, and numerous other reported cracks, forced Aero Commander in 1964 to design reinforcing straps for the spar bend. The first were external retrofits, soon added to production. By 1968 the straps were internal and more elegant. The spar caps still cracked, but the cracks grew more slowly to give time for inspections.

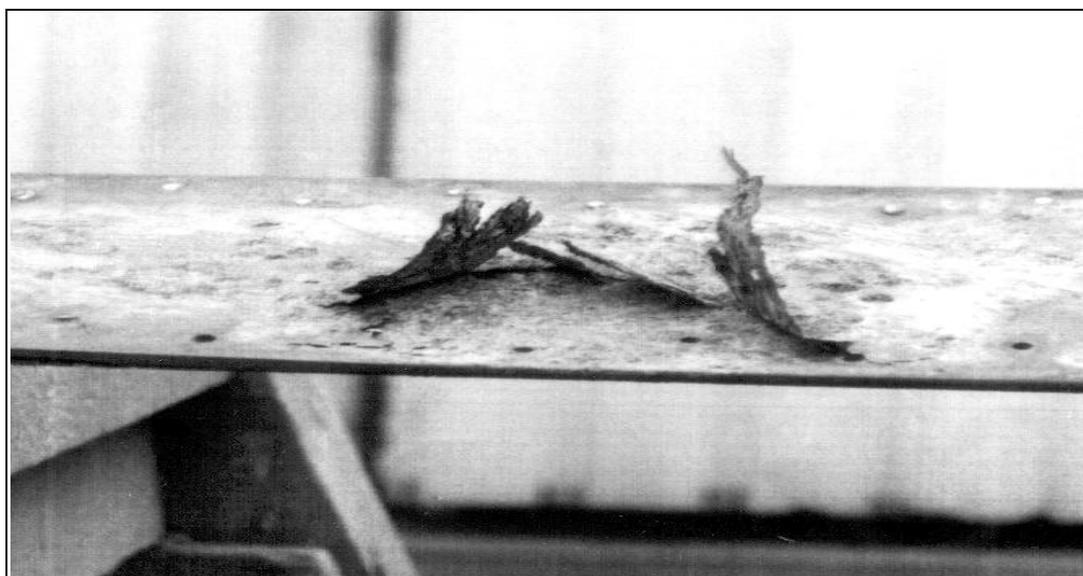
But the straps introduced new problems. The external straps, which only extended fourteen inches outboard of the spar bend, created another fatigue-critical site at the end fasteners. The internal straps were much longer and better for fatigue, but being stainless steel they galvanically corroded the aluminium alloy spar cap.

Exfoliation corrosion in main spar lower cap

Corrosion was first reported in Australia in 1985 and later in the United States. Most Aero Commanders with the stainless steel strap have by now had spar corrosion. Many owners have had to replace the spar cap at great expense. Normally the corrosion has exfoliated, causing a slow loss of spar area. Corroded spar caps have to be inspected more frequently until the corrosion depth exceeds allowable limits.

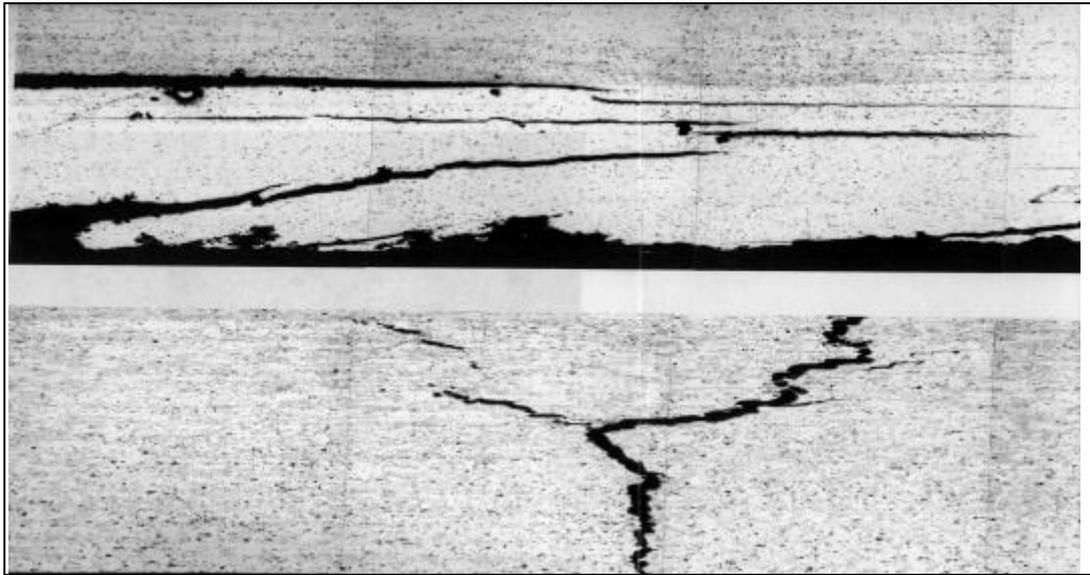
In another twist, in 1991, inspectors looking for corrosion found massive cracks almost right through the spar cap in a couple of aeroplanes. Metallurgical investigation found that the cracks were caused, not by fatigue in this case, but by stress corrosion of a type not normally found in extrusions. The extrusions were faulty in that they had an unusually fine, equi-axed and re-crystallised grain structure. This problem required another set of spar inspections to identify and remove from service all faulty extrusions. A complication was what to do with extrusions which had an intermediate grain structure - there seemed to be little information available to assist those having to make decisions with important safety and financial consequences.

Intergranular corrosion. Upper: exfoliation in a normal extrusion. Lower: stress corrosion in equi-axed grain structure.

| January 1992 | The Australian CAA concluded its investigation of the piece of spar from Aero Commander 690B S/N 11545. In Specialist Report No. X1-92, metallurgist Dr Arjen Romeyn noted that the cracking was a form of stress corrosion not normally found in extrusions because of the highly elongated grains. The grains in this extrusion were unusually fine and equi-axed (re-crystallised) which allowed stress corrosion cracks to traverse easily through the spar cap instead of being deflected to produce exfoliation. |

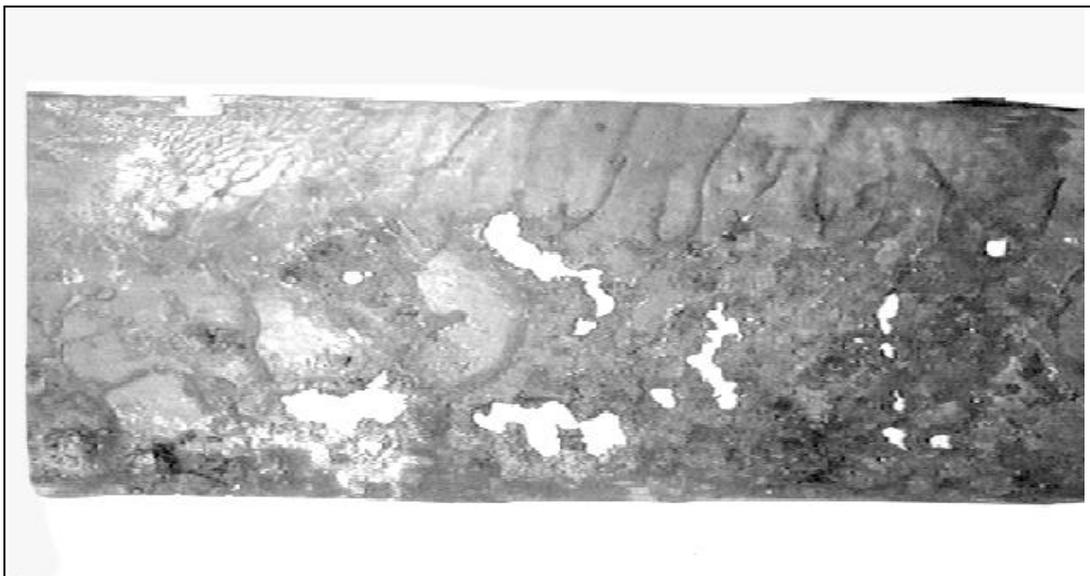
At about the same time another few aeroplanes were found in which the spar caps were intact, but corrosion had eaten large holes in the internal reinforcing straps which were, for some reason, not made from stainless steel. Perhaps there was a supply shortage.

Corroded 4130 steel internal strap

- January 1992 An alert Australian maintenance organisation found the 'stainless steel' internal reinforcing strap in a 500S VH-UJP corroded right through in places. It was not stainless steel, but (unprotected) 4130. Aero Commander could not find records to identify which aeroplanes had which steel, so all aeroplanes had to be checked - with a magnet held up under the lower wing skin. More than a quarter had 4130. Aero Commander and FAA were advised, but by February 1995 had not acted. The fatigue strength of the wing depends on the integrity of the reinforcing strap.

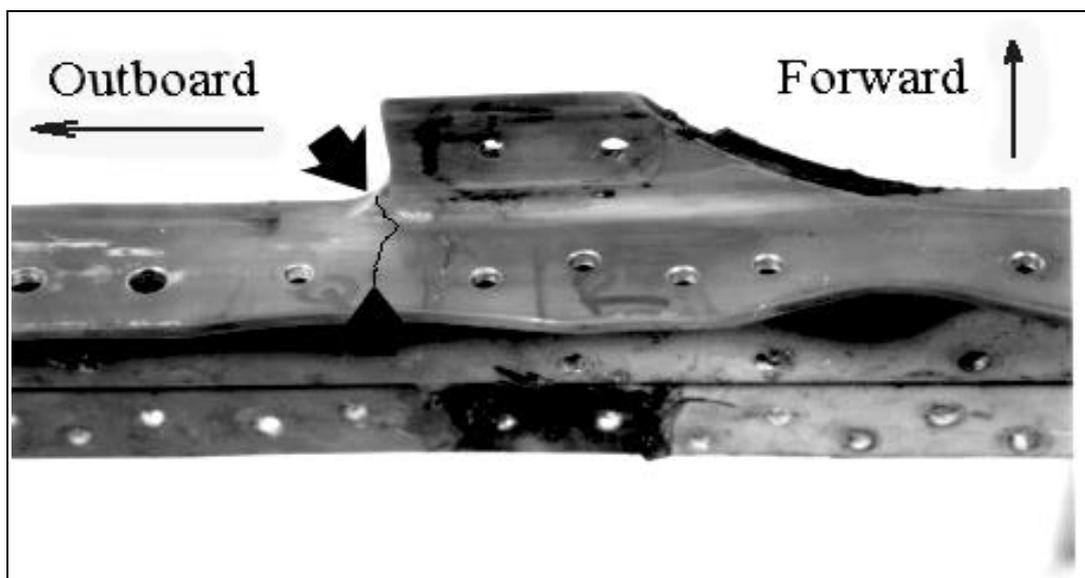
Wing Station 24 - typical crack
