A U S T R A L I A N   T R A N S P O R T   S A F E T Y   B U R E A U

AIR SAFETY INVESTIGATION

**INVESTIGATION REPORT  
200100213**

**Boeing 737-400, VH-TJX  
Brisbane, QLD  
18 January, 2001**

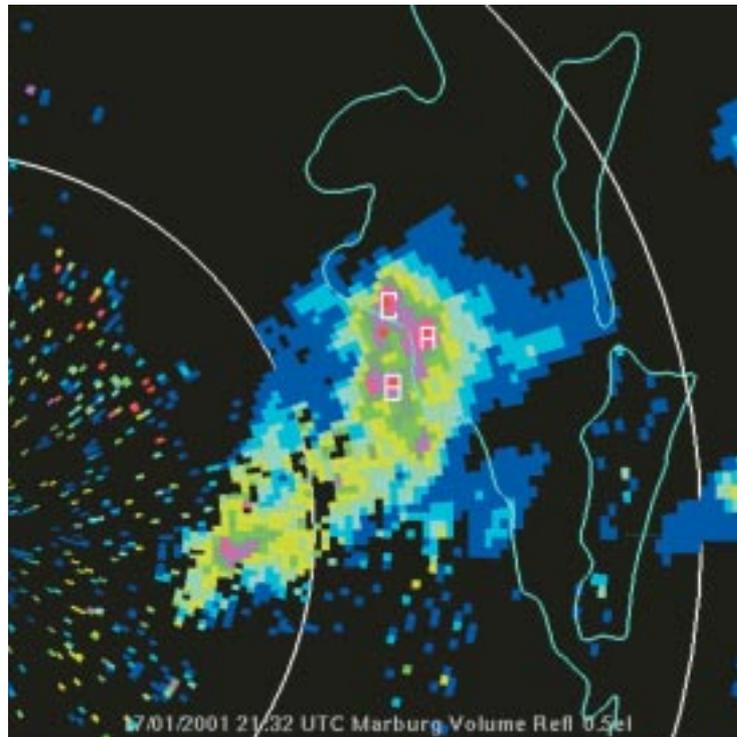
**Figure 6:**  
Marburg Radar – 18 January 2001, 0722 EST expanded data

Figures 6 and 7 are higher resolution images showing the movement of the storm during the same period. The solid black line shows the position of runway 19 at Brisbane aerodrome. The location of the BoM anemometer is shown with a '+', adjacent to the threshold of runway 19. The radar data revealed that thunderstorm cells A and B passed south of runway 19, and that thunderstorm cell C developed over the runway during the period 0722 to 0732.
