ATSB TRANSPORT SAFETY REPORT

Aviation Research and Analysis - AR-2009-041

Avoidable Accidents No. 1

Low-level flying

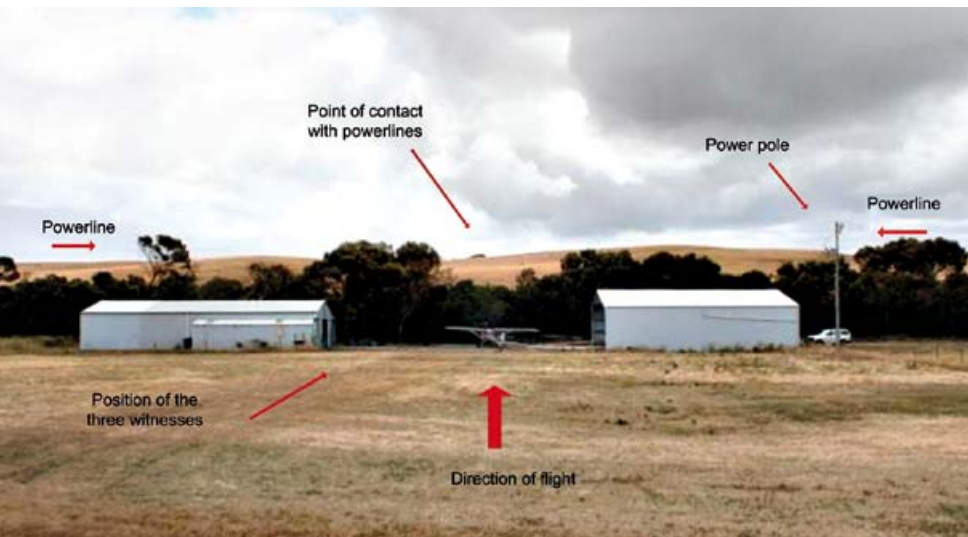
Accident location
