**ATSB TRANSPORT SAFETY REPORT**

Aviation Research and Analysis - AR-2009-041

**Avoidable Accidents No. 1**

# **Low-level flying**

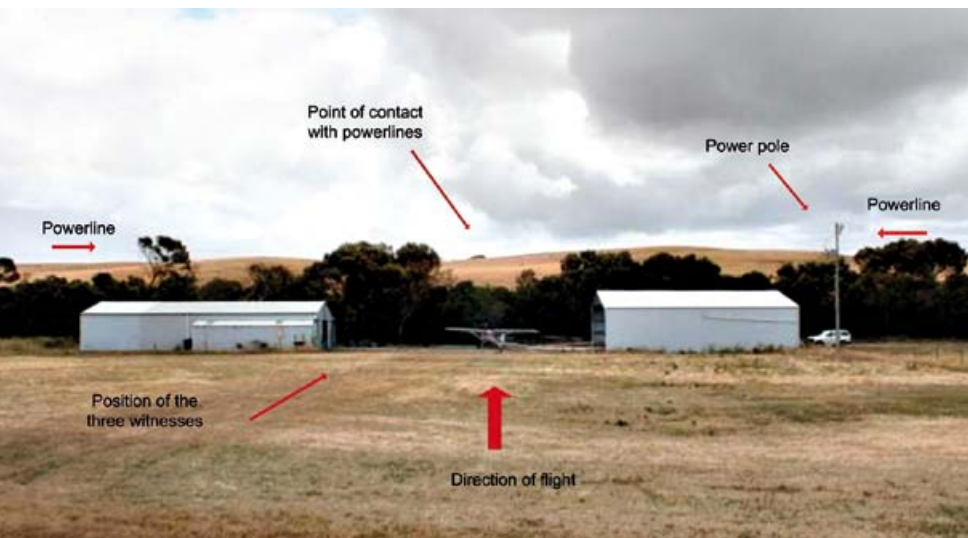
As the aircraft approached the hangars, it climbed suddenly and hit powerlines that passed across the gap between the hangars. Investigation of the wreckage found that the aircraft propeller took the full force of the wirestrike, causing the propeller to disintegrate and the engine to stop. The aircraft aerodynamically stalled at a low altitude, possibly due to the pilot's attempt to avoid trees directly behind the powerlines. Due to the pilot's low altitude, he had little margin to recover from the stall, and the aircraft impacted the ground almost vertically. The pilot sustained serious head injuries, and did not survive.

*Accident location*
