**ATSB TRANSPORT SAFETY INVESTIGATION REPORT**

Technical Analysis Occurrence Report – 200601173

**Microlight Structural Analysis**  
**Airborne Edge**  
**Aircraft Registration: 32-4456 and 32-4388**

Microlight Structural Analysis, Airborne Edge, Aircraft Registration: 32-4456 and 32-4388

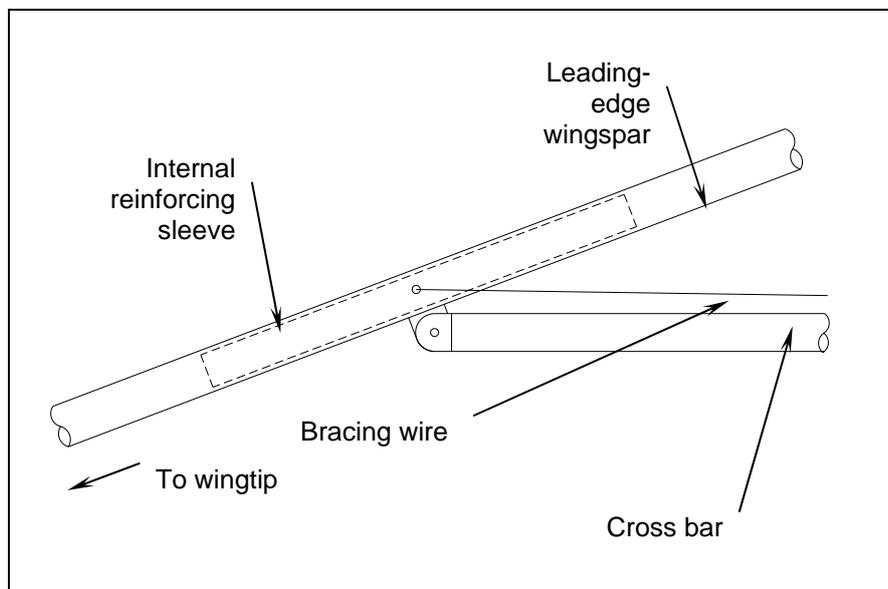
The wire bracing extended out to the intersection of the cross bar and leading-edge wingspar. At this point, the leading-edge wingspar had been reinforced by an internal sleeve of tubular aluminium alloy, see figure 2.

**Figure 2: Leading-edge wingspar with reinforcing sleeve.**

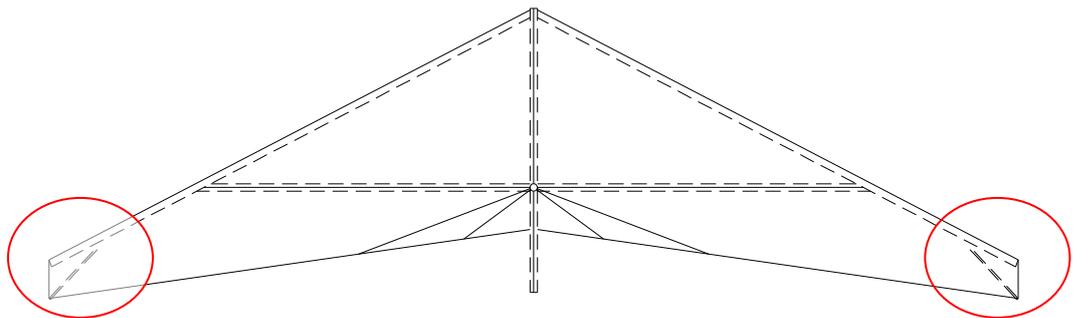
Review of photographs of the Airborne Edge microlight<sup>2</sup>, indicated that the wing adopts a degree of twist while in flight. Twist will effect the load distribution by shifting some of the lift from the tips inboard (i.e. more lift is generated in the middle of the wing). Given the structural restraint of the tip struts and battens located at the tip of the trailing edge of the wing, see figure 7, the aerofoil at the wing tip must adjust and try to align with the relative airflow. This results in a smaller amount of lift generated near the wing tips due to a reduced angle of attack to the relative airflow.

**Figure 7: Circled are the wing tip struts that act as structural restraints to the wingspar (battens are not shown in this diagram).**
