ATSB TRANSPORT SAFETY INVESTIGATION REPORT

Aviation Occurrence Report – 200601688

Engine power loss – Bankstown Airport – 5 April 2006

Amateur-built Lancair 360

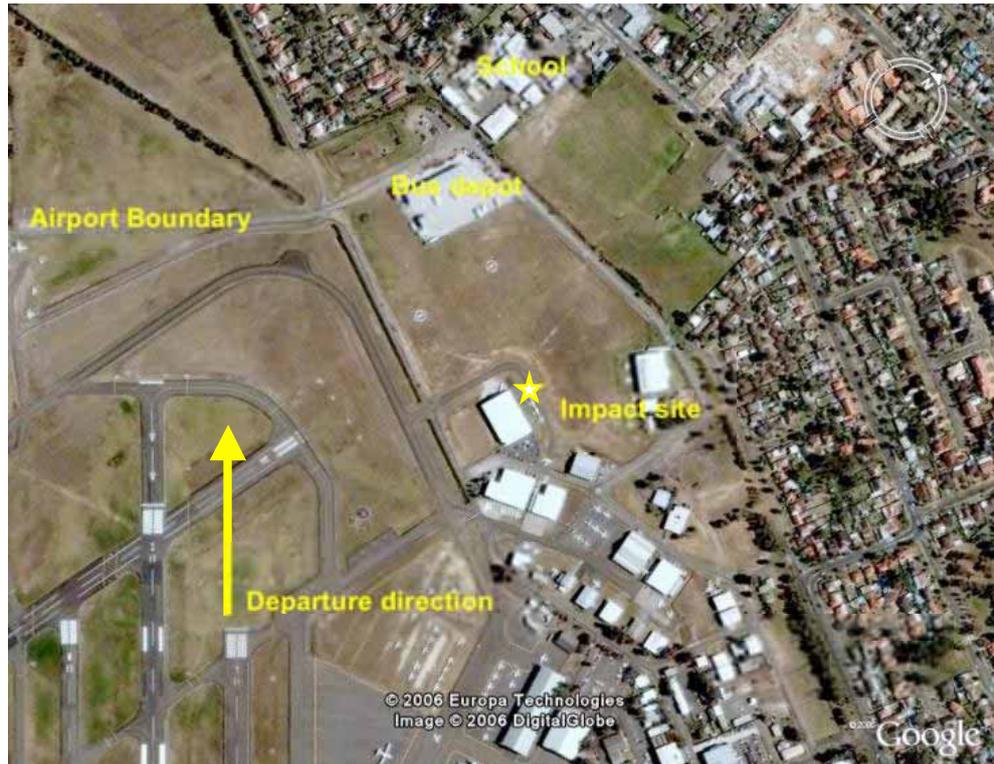
Figure 1: Accident location at Bankstown Airport

At a position corresponding to an early downwind position of a very close circuit and at a height not above 500 ft, the turn was seen to quickly steepen and the aircraft's nose dropped into a steep descent. The majority of witnesses reported that the engine noise ceased at about the same time. When close to the ground, the aircraft's nose was seen to rise and the wings move towards level, but the rapid descent continued and the aircraft heavily impacted a taxiway on the north-western part of the airport (figure 1). The pilot was fatally injured and the aircraft was destroyed.

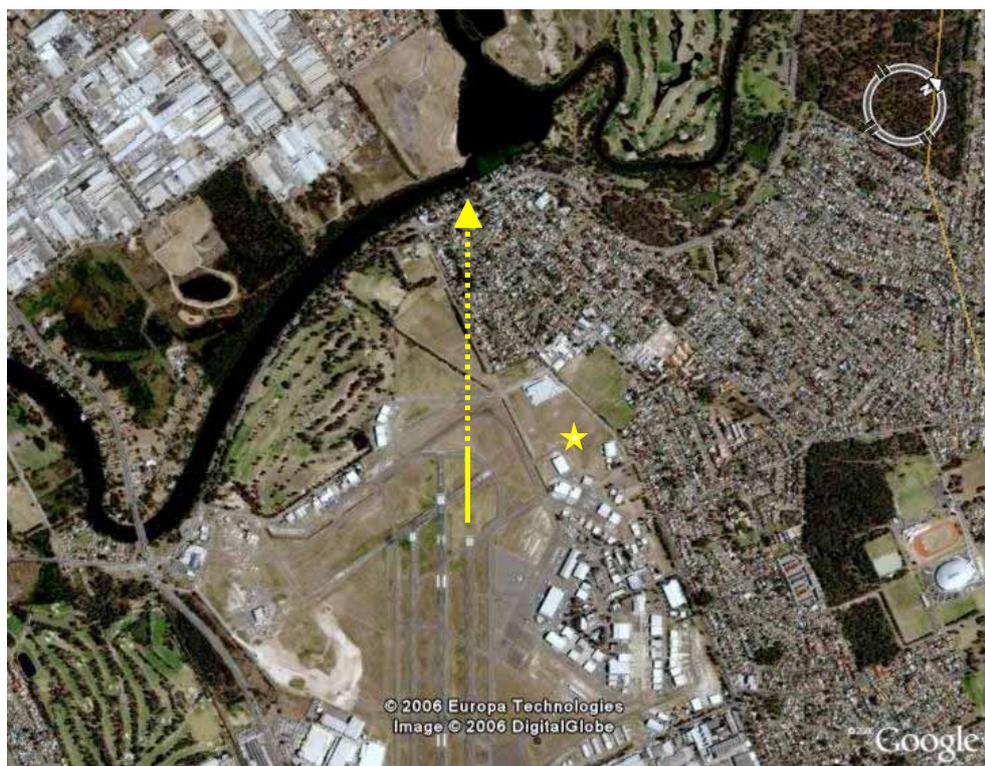
Figure 2: Area to north-west of Bankstown Airport

In figure 2 the extended centreline of runway 29R is depicted as a series of dots and the accident site as a star. Outside the airport boundary, the area adjacent to the extended centre line of runway 29R was generally populated with houses and was bounded by a river. To the left of the extended centreline was a non-populated area and golf course, also bounded by the river.

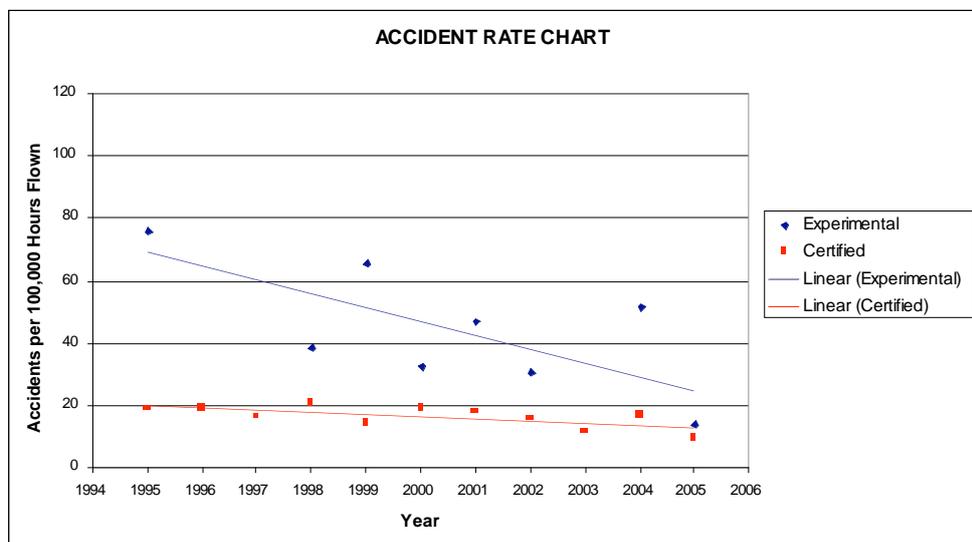
Figure 7: Accident rate chart

The accident rates were plotted on a chart (figure 7) and a trendline derived. The trendline for amateur-built aircraft accident rates shows, that the line is converging with the accident rate trend for comparable certified fixed-wing single-engine aircraft.
