RESEARCH REPORT  
B2003/0114

# Review of Midair Collisions Involving General Aviation Aircraft in Australia between 1961 and 2003

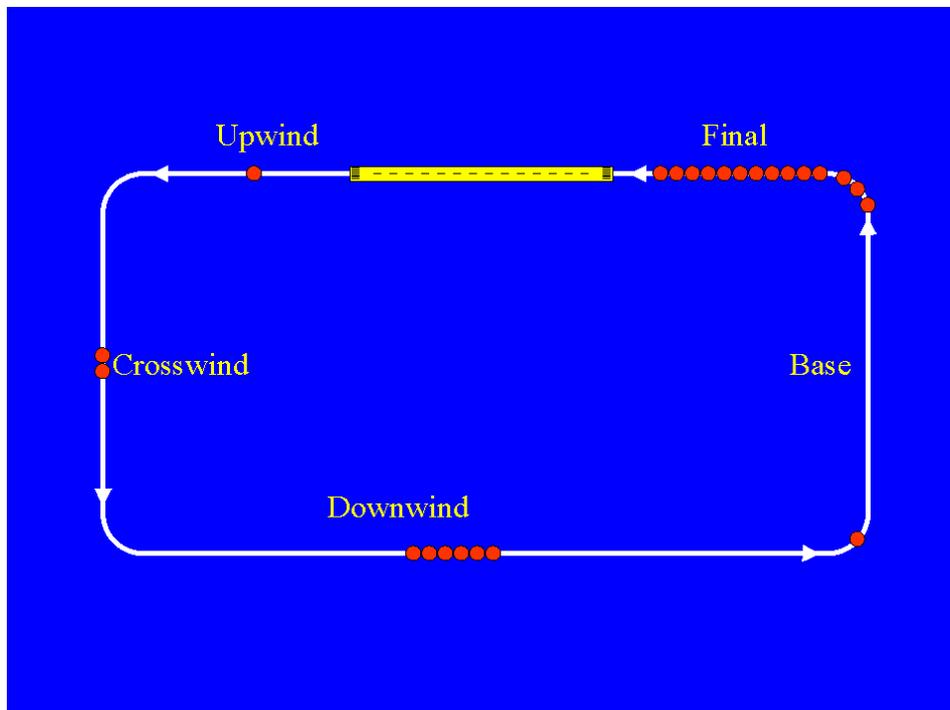
**Figure 1: Diagrammatic representation of positions of midair collisions in the circuit area**

The diagram does not discriminate between left and right circuit patterns.

Eleven of the collisions occurred when both aircraft were on final approach, two occurred during the base-to-final turn, and one occurred on the turn to base. The collision at Moorabbin in 1968 occurred either on the base leg or the final approach. Six collisions occurred on the downwind leg (one with an aircraft departing) and two occurred on the crosswind leg (one with an aircraft departing). One collision involved two aircraft on initial climb. Figure 1 presents a diagrammatic representation of the location of collisions in the circuit area. The dots indicate in which leg of the circuit the collisions occurred rather than the specific location within each leg.

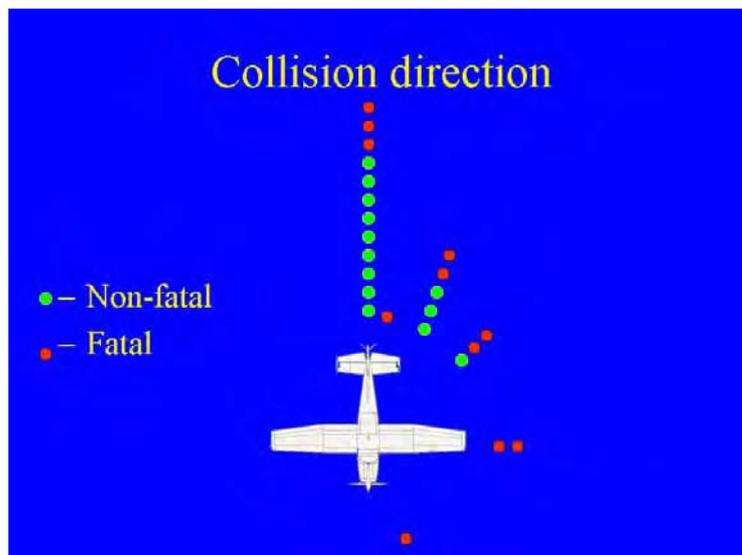
**Figure 2: Diagrammatic representation of collision angles involved in collisions not involving deliberately close flying activities**

The diagram does not include collisions with gliders, or collisions where aircraft were flying deliberately close.

- Most (18) of the collisions involved one aircraft colliding with another from behind, or both aircraft converging from a similar direction (less than 30 degrees difference in heading), and only six of these collisions resulted in fatalities. Twelve of these collisions occurred at a height of 250 ft or less above the ground, with only three resulting in fatalities. Of the 12 collisions with collision angles 30 degrees or greater, 11 resulted in fatalities.<sup>11</sup> All of these collisions occurred at heights greater than 250 ft. Figure 2 provides a diagrammatic representation of the collision angles involved in the midair collisions.
